## Structural Building Inspection Report

INSPECTION DATE: November 19, 2009

**Address of Residence Inspected:** 3901 & 3895 NE 4<sup>th</sup> St, Renton WA  
98056

**Type of Residence:** Single Story Strip Mall. Two Buildings

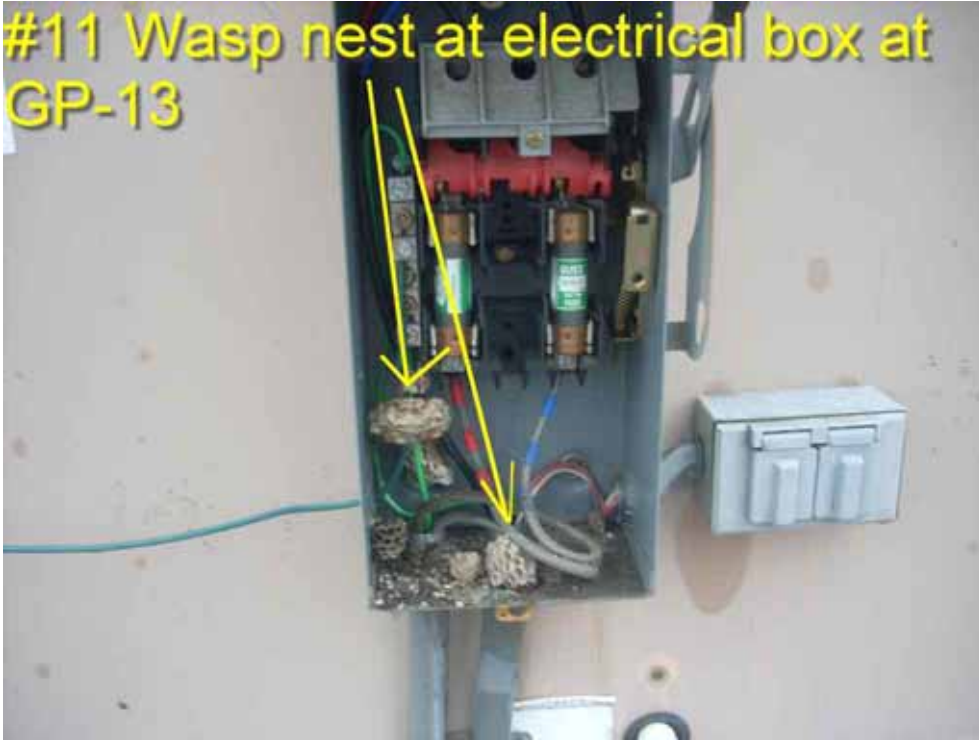
1. There is a wasp nest inside the electrical shut off box for GP-13 (See Photo#11)
2. There are some cover plates missing on the switch boxes on the roof of Bldg.3901. If the access to roof is compromised, as it is with Bldg.3895, this could result in lawsuit if someone were to get onto the roof and got shocked. (See Photo#12, 13)

#11 Wasp nest at electrical box at GP-13

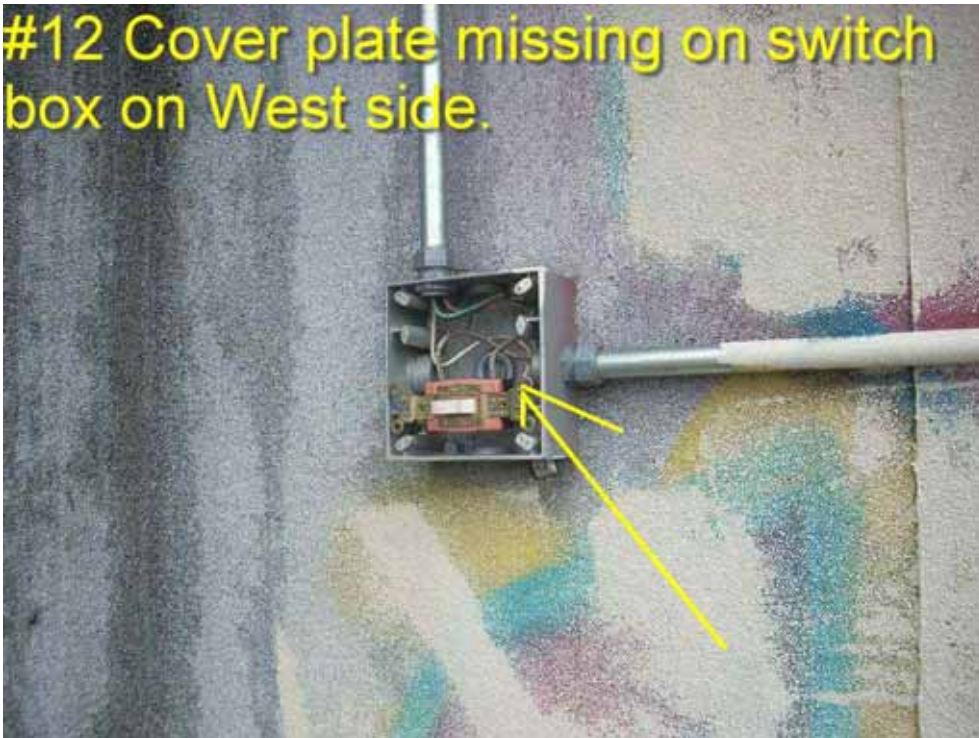
#12 Cover plate missing on switch box on West side.

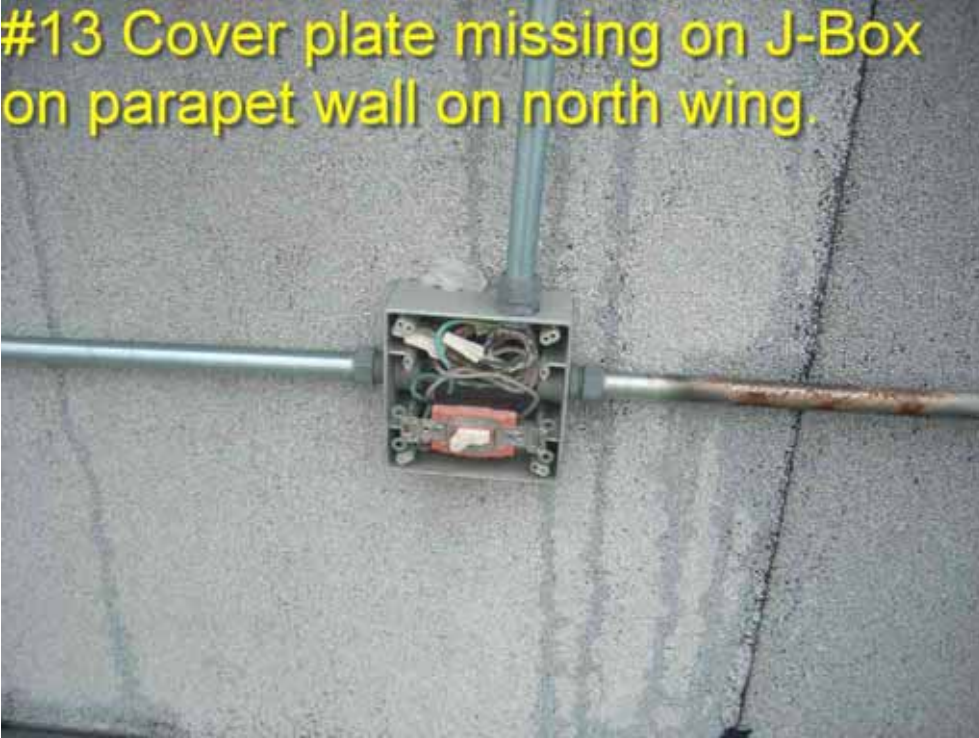
#13 Cover plate missing on J-Box on parapet wall on north wing.

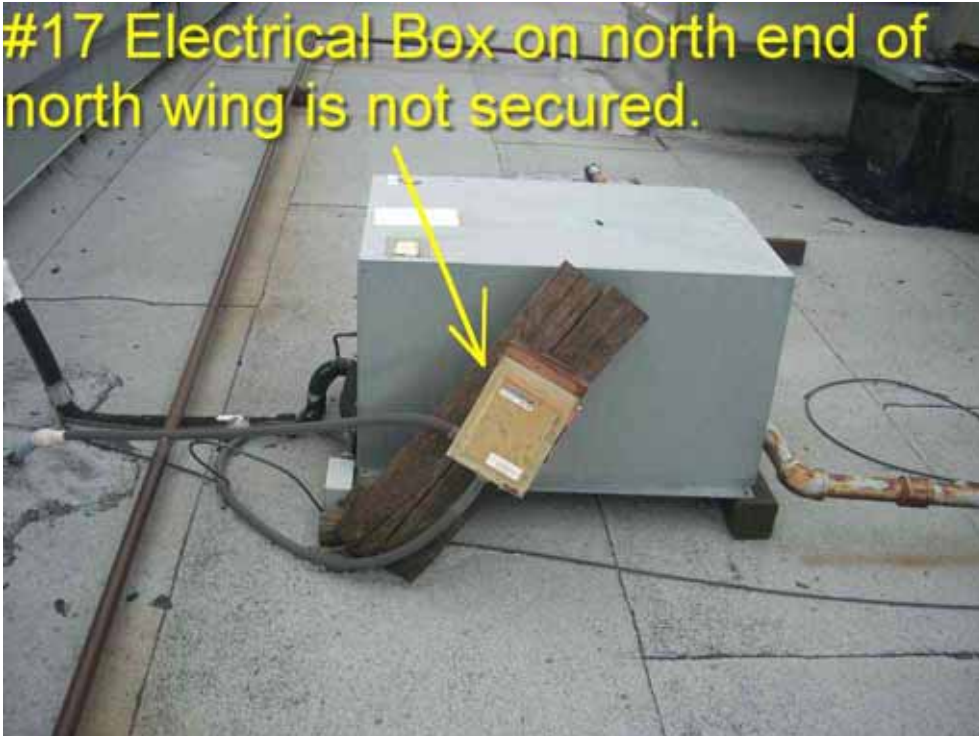
#17 Electrical Box on north end of north wing is not secured.

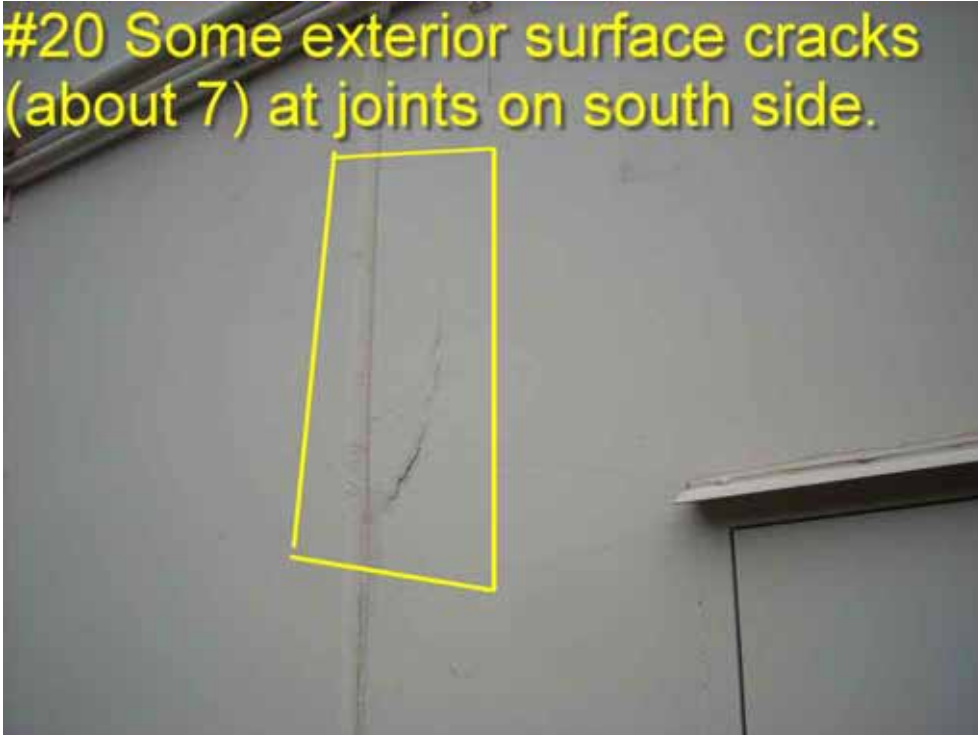
6. The grease trap and hose on the roof above unit 105 is broken. (See Photo#19)
7. There are a number of surface cracks on the south side concrete tilt up walls. This either occurred during construction or during the recent earth quake in 2000. These are cosmetic issues. (See Photo#20)

#20 Some exterior surface cracks (about 7) at joints on south side.

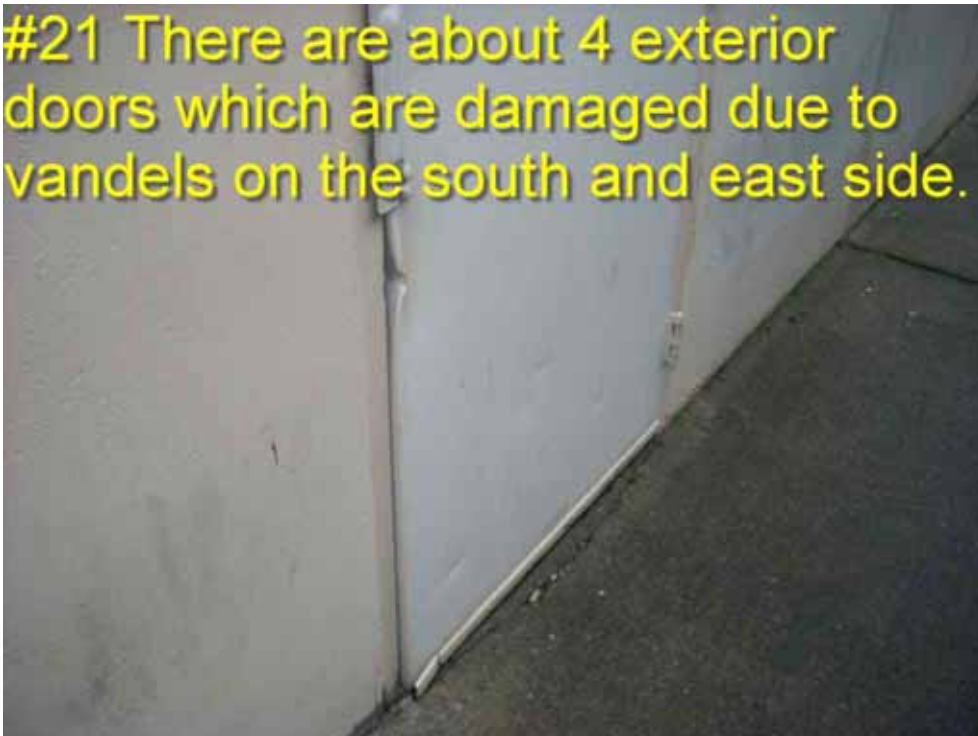
8. There are about 5 exterior doors on the south and east side which have been damaged due to vandalism. (See Photo#21, 22)
9. There is breaker plug missing at the 200 amp panel in the electrical service room. (See Photo#23)

#21 There are about 4 exterior doors which are damaged due to vandels on the south and east side.

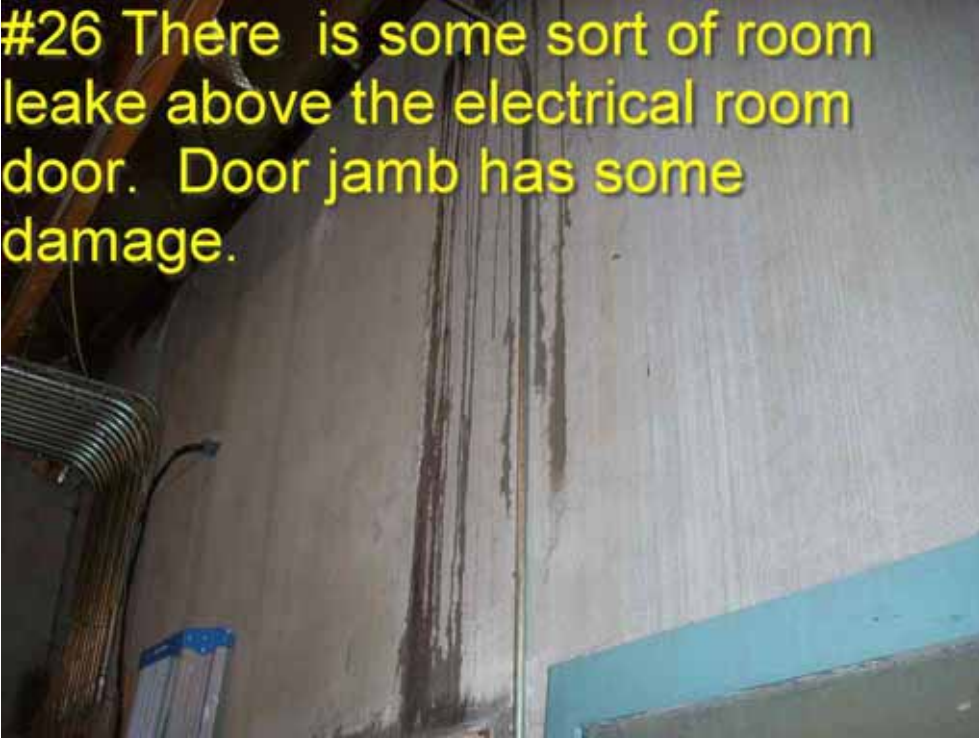
#26 There is some sort of room leak above the electrical room door. Door jamb has some damage.

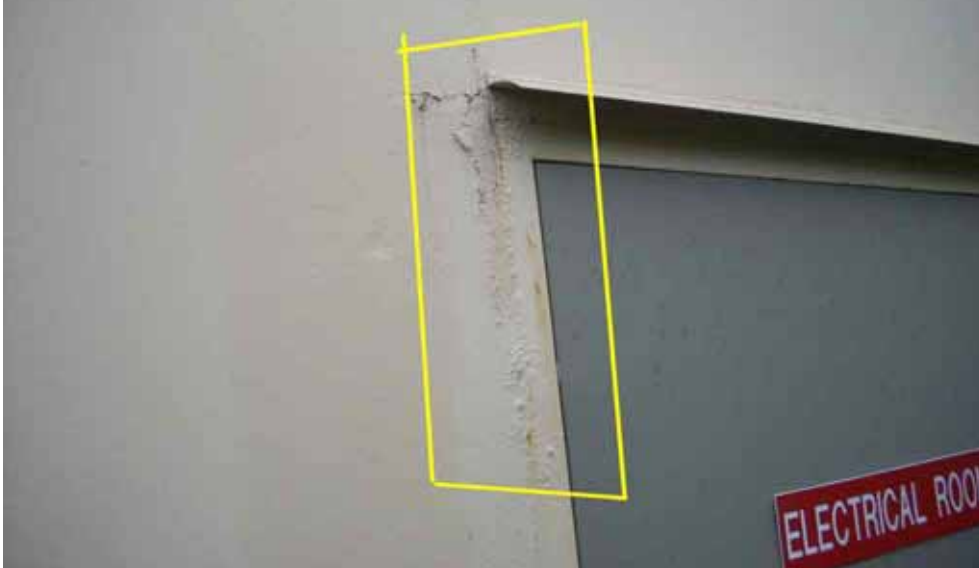
#27 Water appears to be wicking over the top of the parapet wall and down to the vent above the electrical room.

#28 Rust damage to electrical room door.

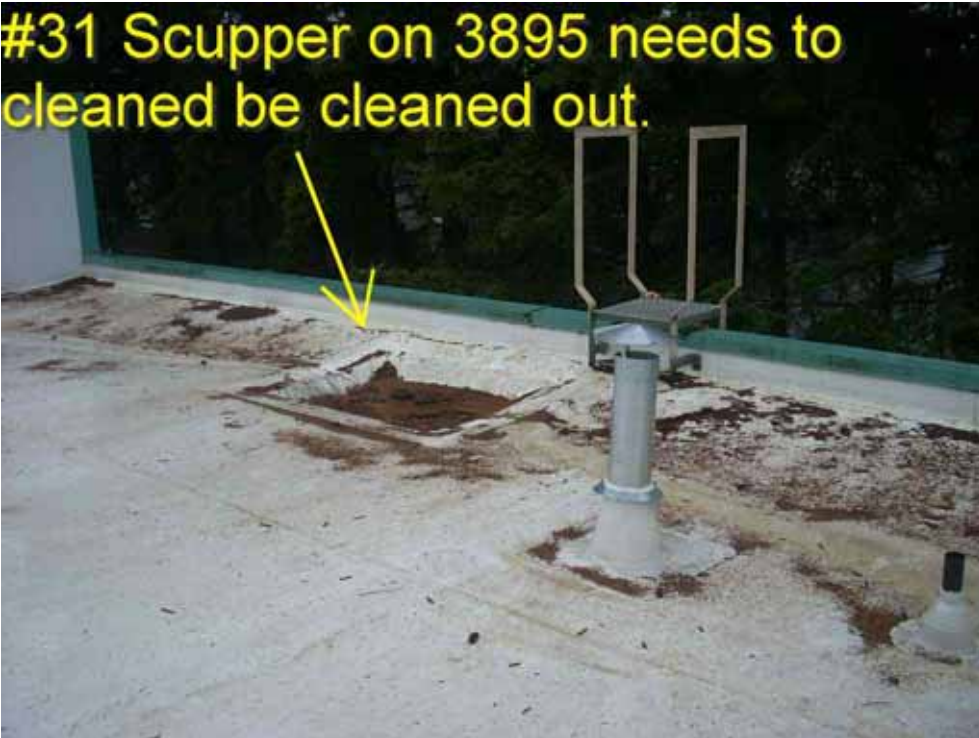
#31 Scupper on 3895 needs to be cleaned out.

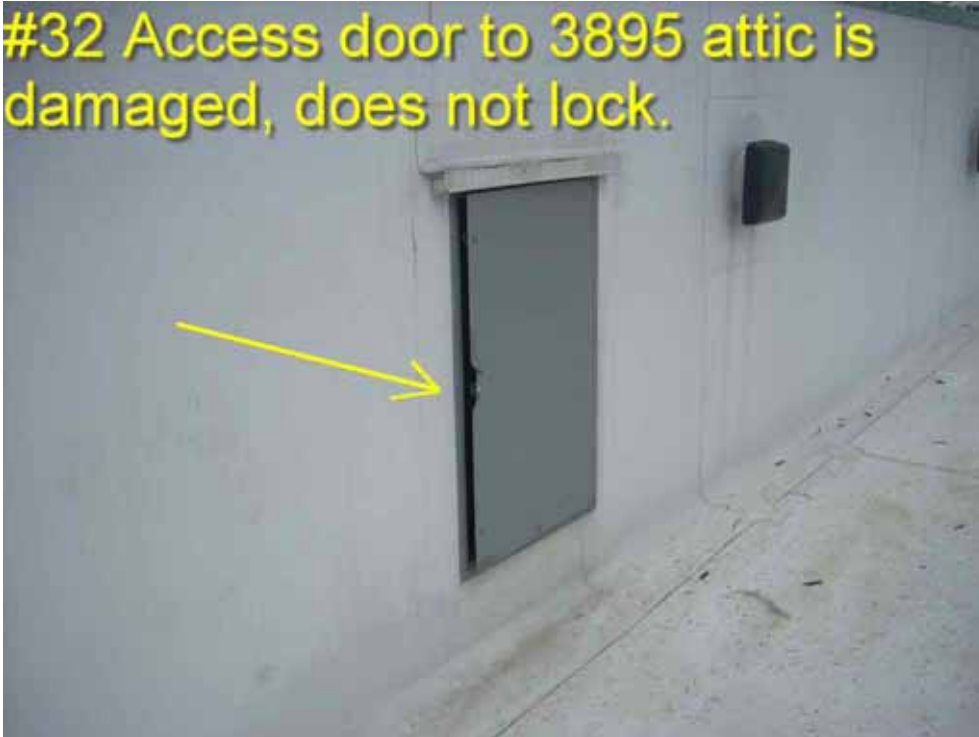
12. The attic door panel on Bldg.3895 has a broken door lock. (See Photo#32)
13. The SE drain pipe on Bldg.3985 has a crushed downspout drain pipe. (See Photo#34)

#32 Access door to 3895 attic is damaged, does not lock.

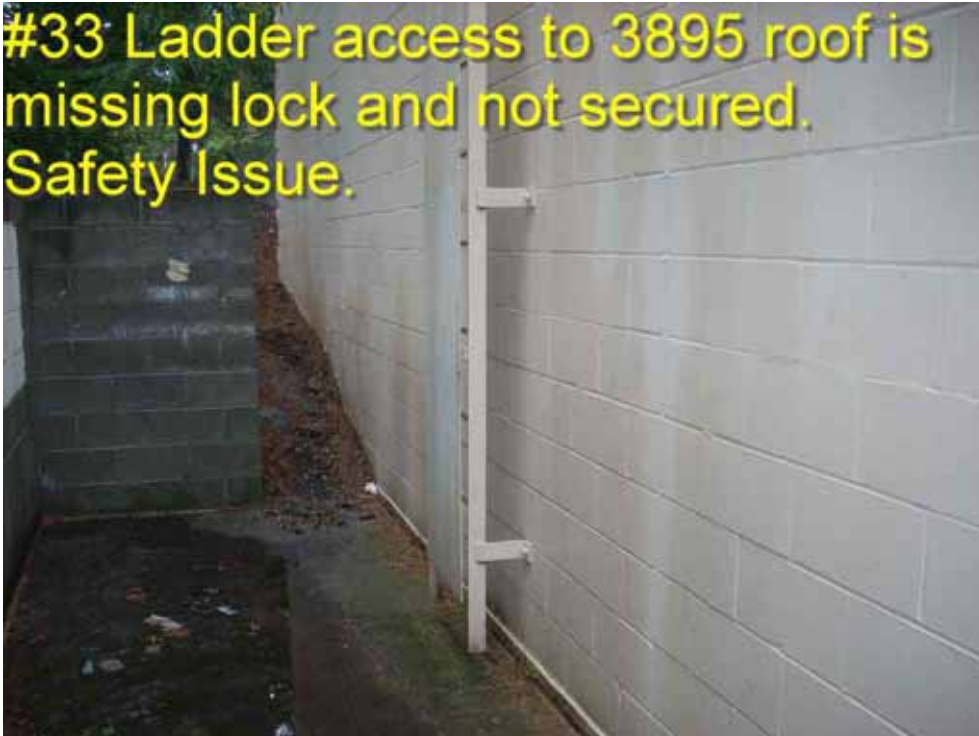
- a. The roof ladder for Bldg.3985 is not secured to out non-service personnel. This is safety liability which could result in a lawsuit. (See Photo#33)

#33 Ladder access to 3895 roof is missing lock and not secured. Safety Issue.

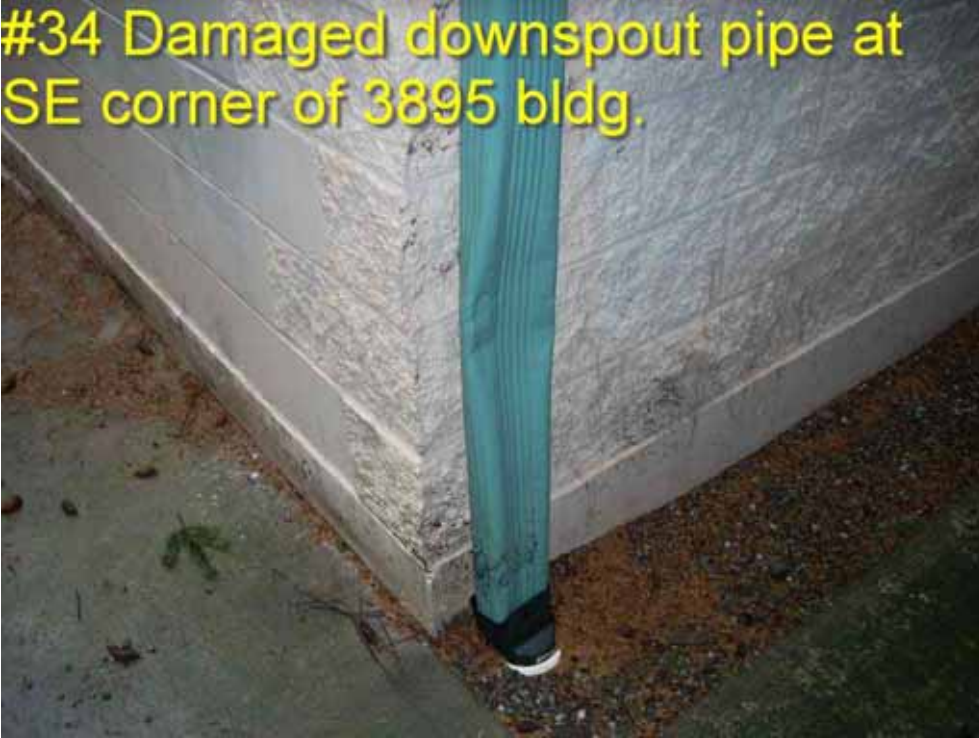
#34 Damaged downspout pipe at SE corner of 3895 bldg.

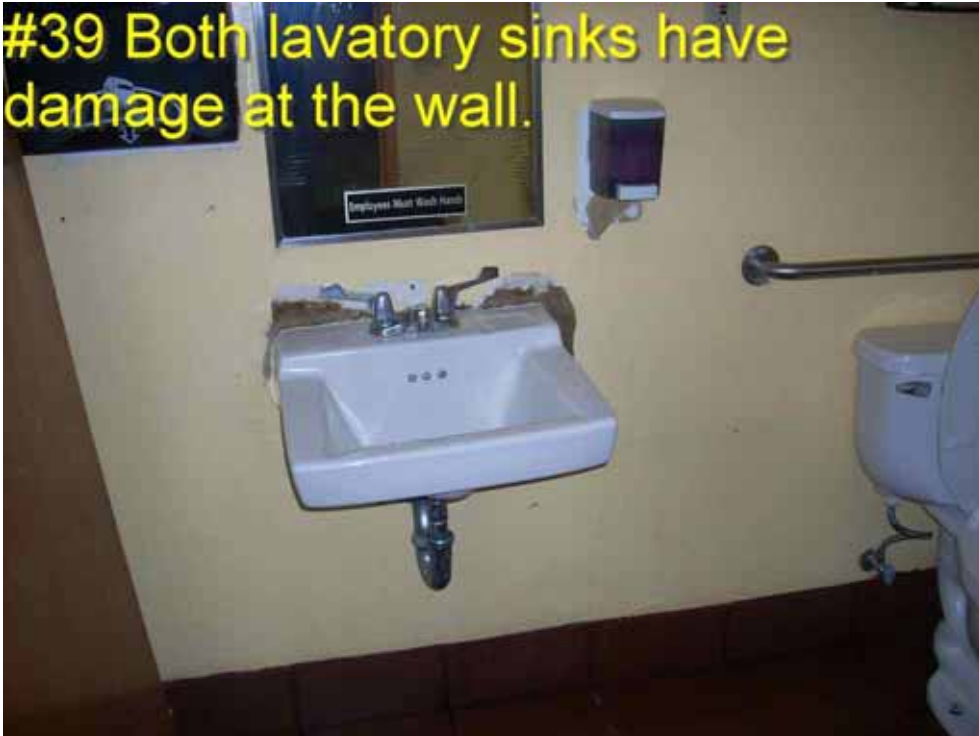
14. Both lavatory sinks in Unit-112 are loose and have damaged wall areas. Lavatory sink in unit-110 is loose too. (See Photo#39, 45)
15. The lavatory divider in the mens room of unit 105 is water damaged. (63)

#39 Both lavatory sinks have damage at the wall.

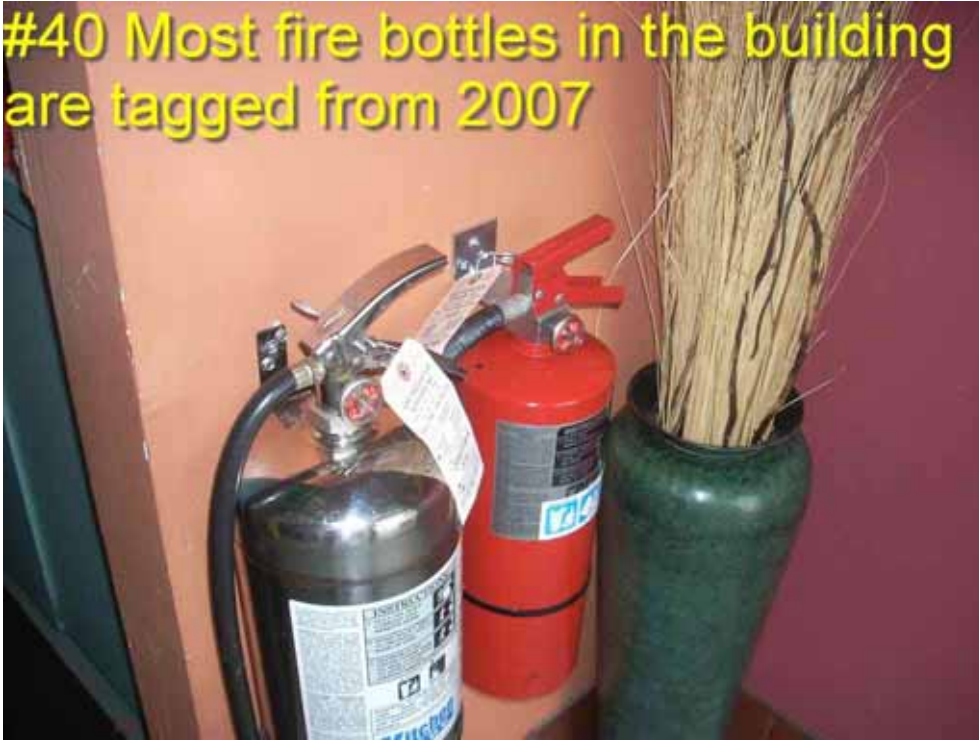
- b. Most of the fire extinguisher bottles are either tagged in 2007 or are missing tags. This could be a liability issue for the owner, (See Photo#40, 44, 49, 51, 55)

#40 Most fire bottles in the building are tagged from 2007

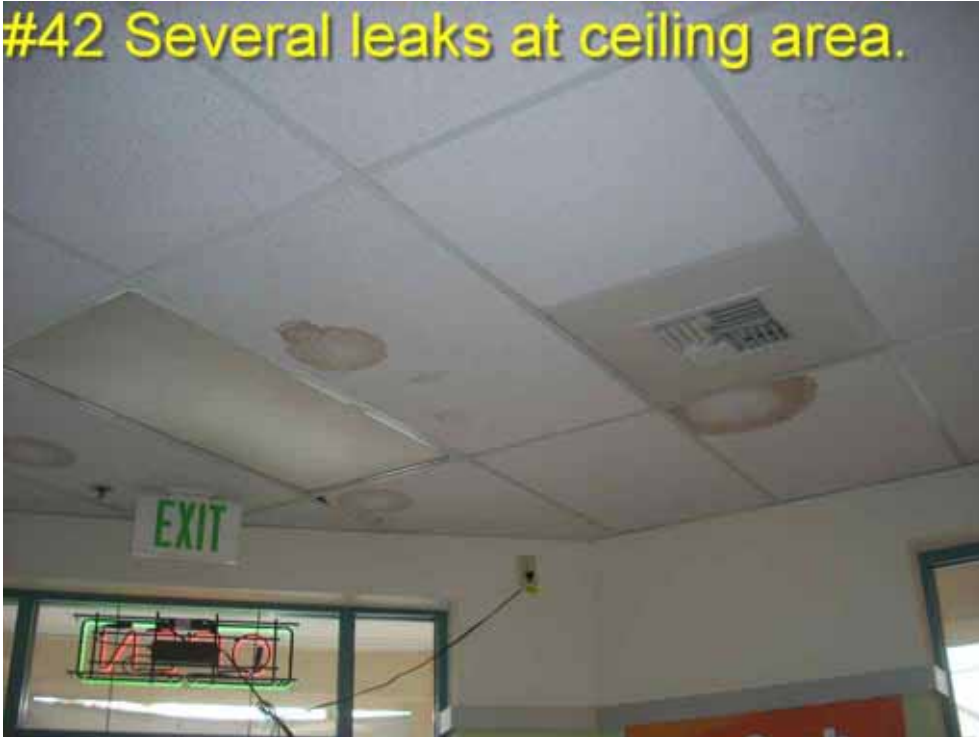
- a. The interior of Bldg.3901 has a surprising number of roof leaks. Most of these are mapped on the pest diagram found on the last page of this report. (See Photo#42, 47, 52, 53, 59, 62, 69, 70, 71, 72, 73, 75, 76, 77, 78, 80, 81, 90, 91)
- b. There is a roof leak above the electrical service room door. The water appears to wicking over the parapet wall. The door jamb has been damaged. (See Photo#26, 27, 28)
- c. Bldg.3895 has a clogged scupper trap. Have this cleaned now. (See Photo#31)
- d. There is wood rot at the kitchen wall near the spray and wash area in Unit-105. The wall should have a metal back splash to prevent water damage. (See Photo#60, 61)
- e. There are some cracks in the stucco around the windows on the north end of Bldg.3901. These cracks are letting water into the wall area and are causing hidden damage. (See Photo#82, 83, 84, 85)

#42 Several leaks at ceiling area.

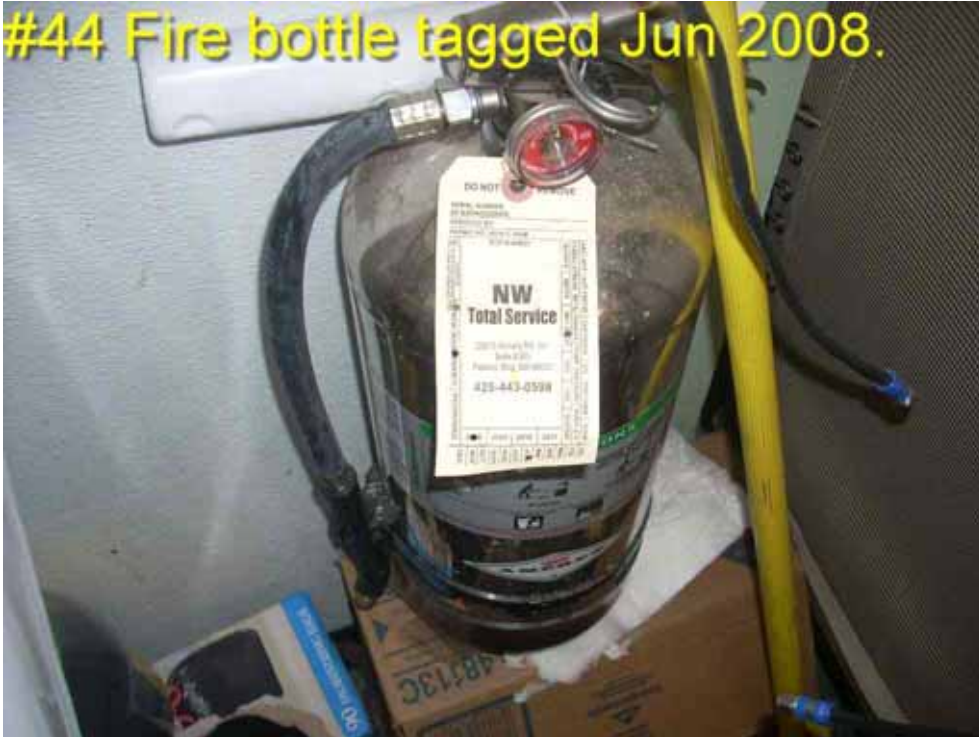
#44 Fire bottle tagged Jun 2008.

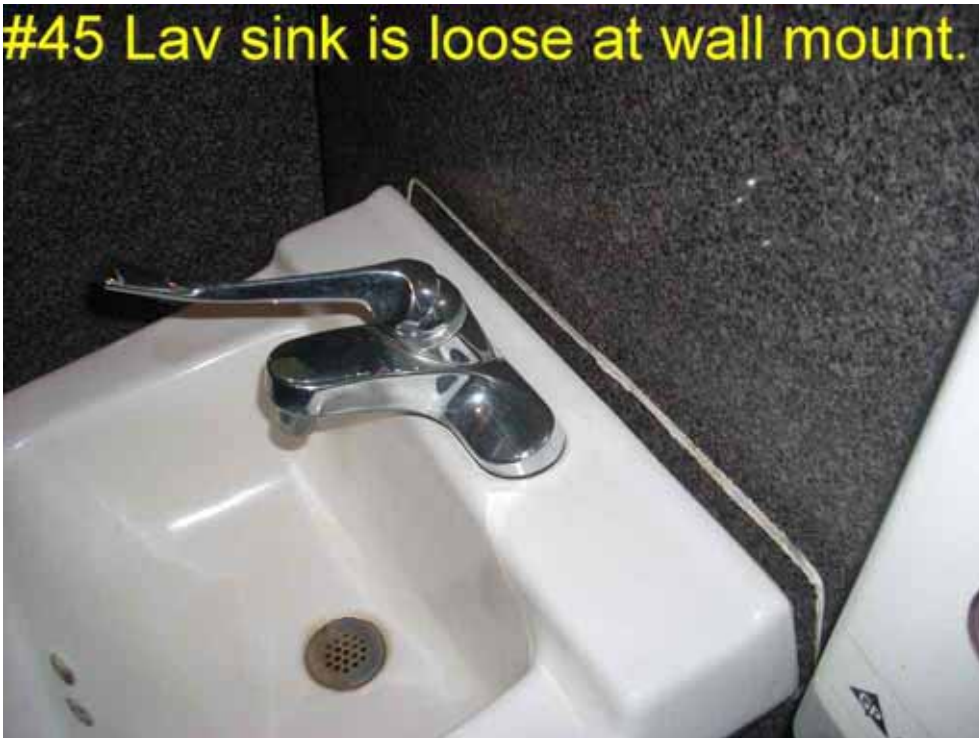
#45 Lav sink is loose at wall mount.

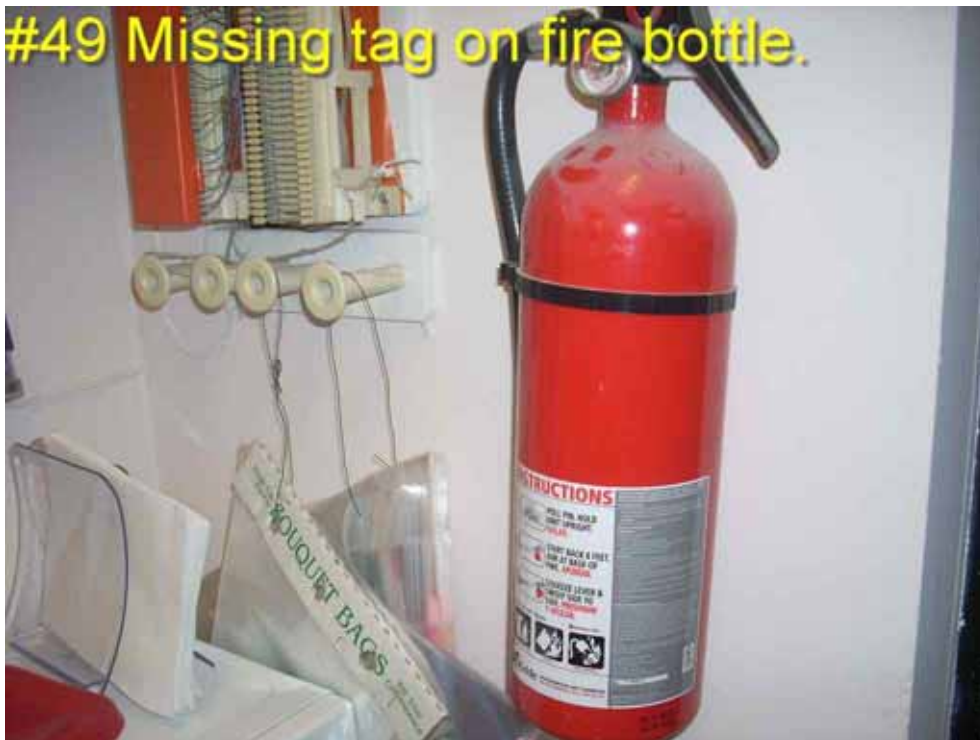
#49 Missing tag on fire bottle.

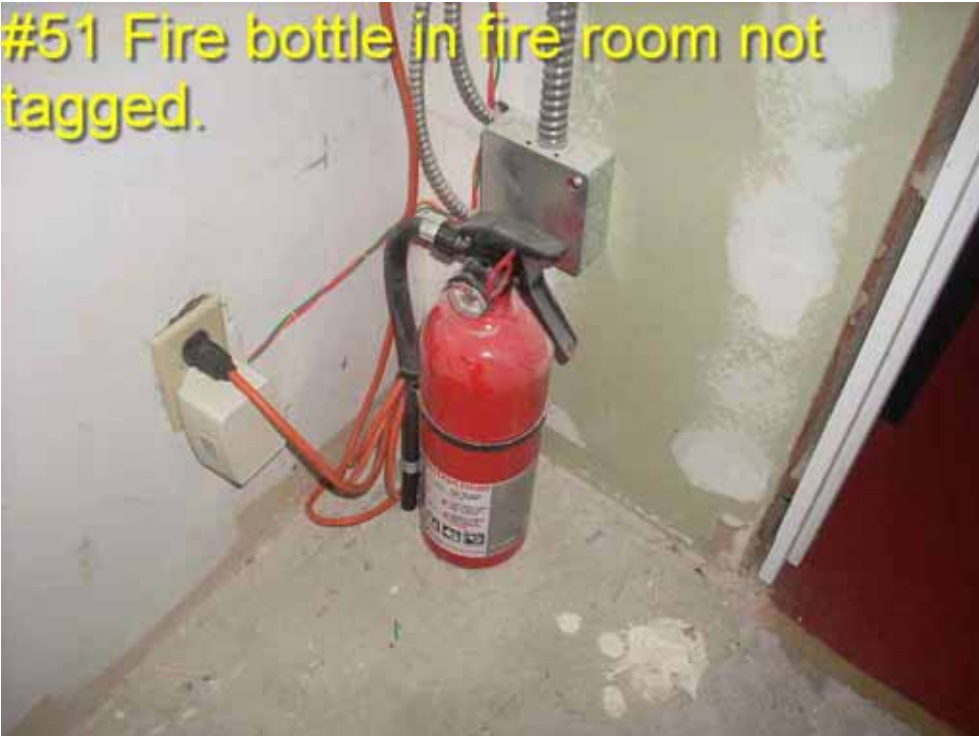
#51 Fire bottle in fire room not tagged.

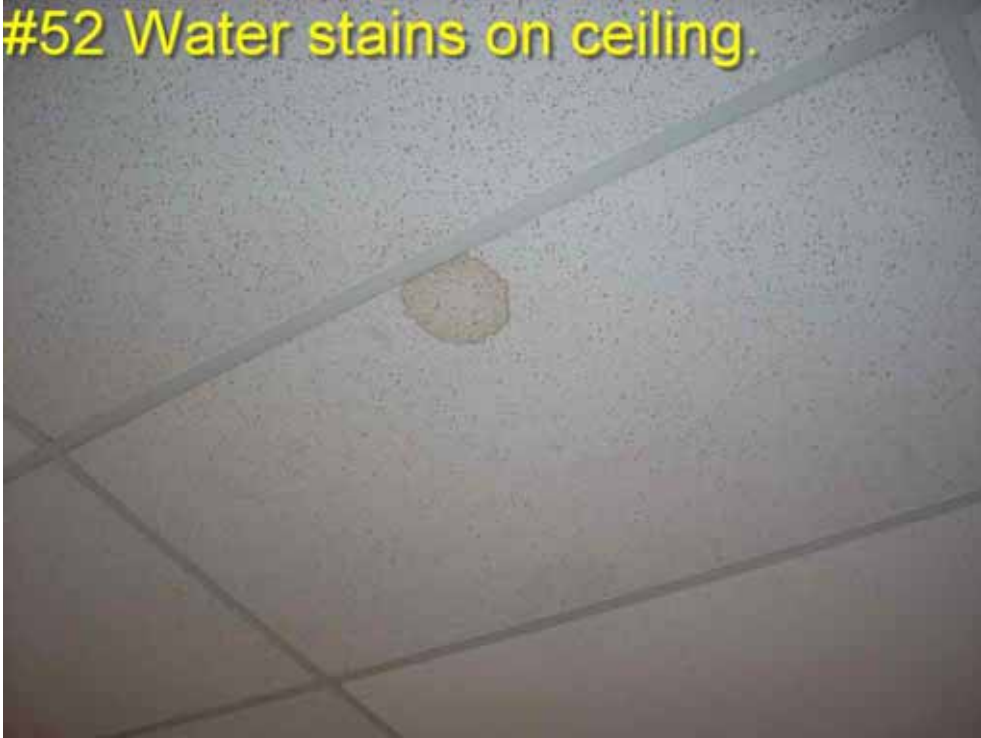
#52 Water stains on ceiling.

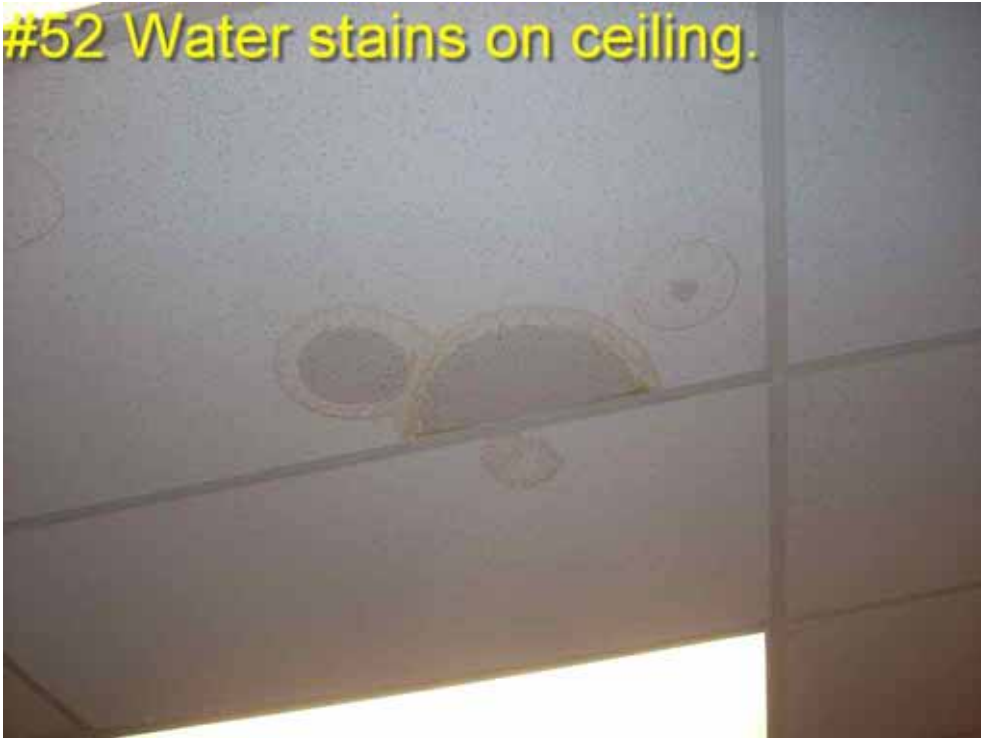
#52 Water stains on ceiling.

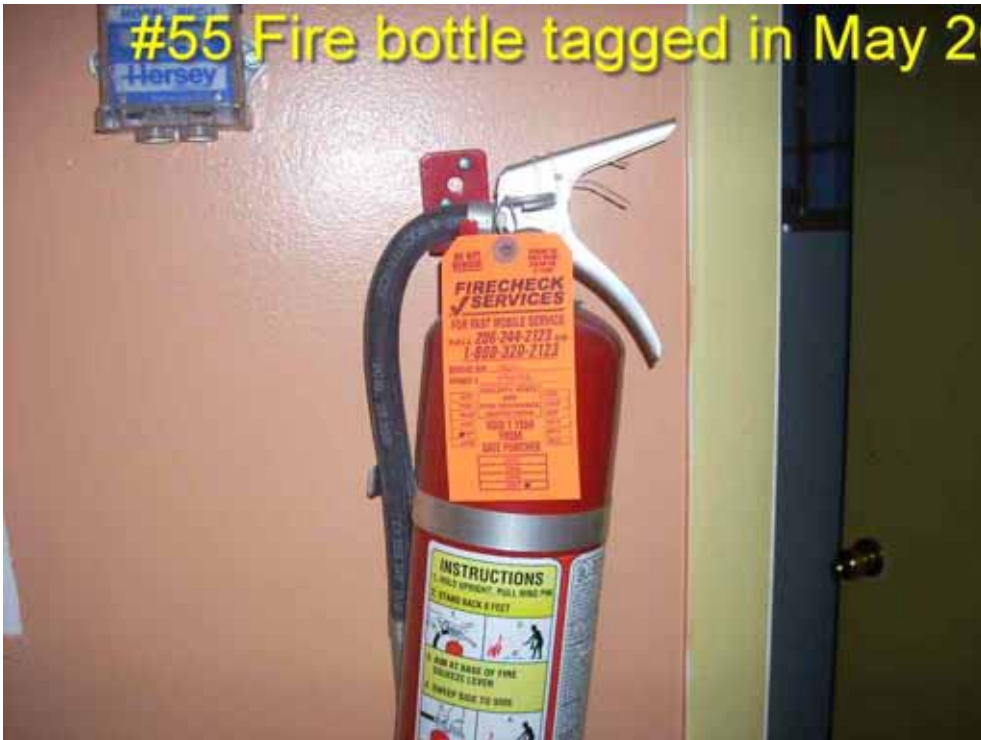
#55 Fire bottle tagged in May 20

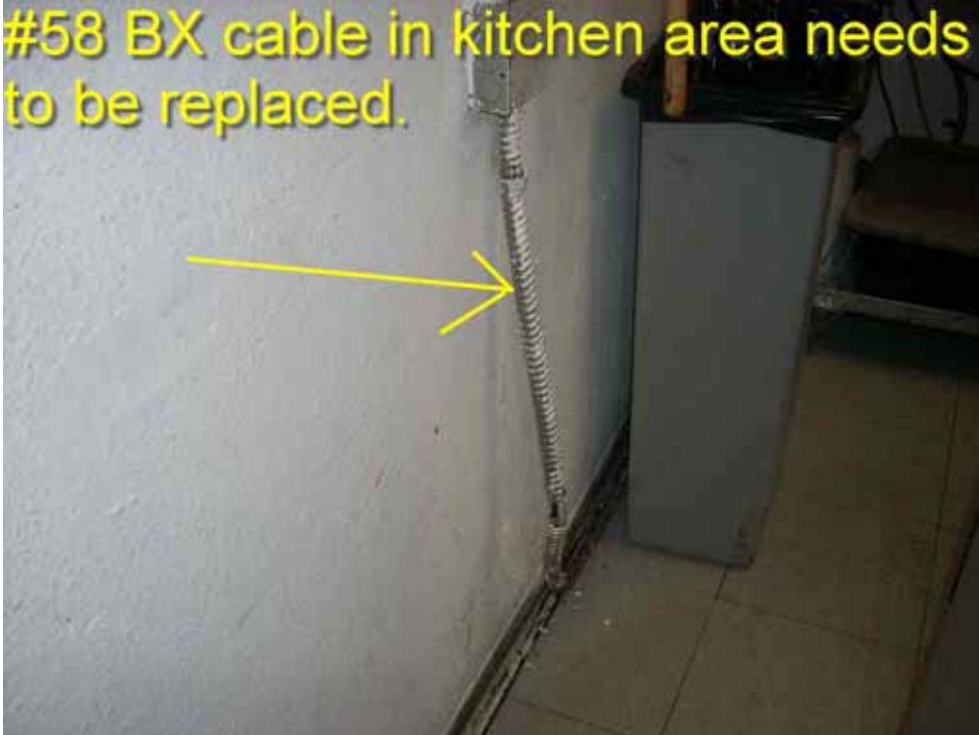
- a. HVAC unit GP-13 has a bootlegged electrical ground to a satellite dish. (See Photo#10)
- b. There is an unsecured shut-off box on the north end of Bldg.3901. Electrical Code Issue.
- c. There is exposed wiring at the BX cable in the kitchen area of Unit-105. Replace the BX cable shielding. (See Photo#58)
- d. The light cover plate is missing in the bar area of Unit 105. This is a litigation possibility. (See Photo#64)
- e. The exhaust fan timer is not secured in the cover plate. A child could stick his fingers in the J-Box easily. This is a possible litigation issue. (See Photo#79)

#58 BX cable in kitchen area needs to be replaced.

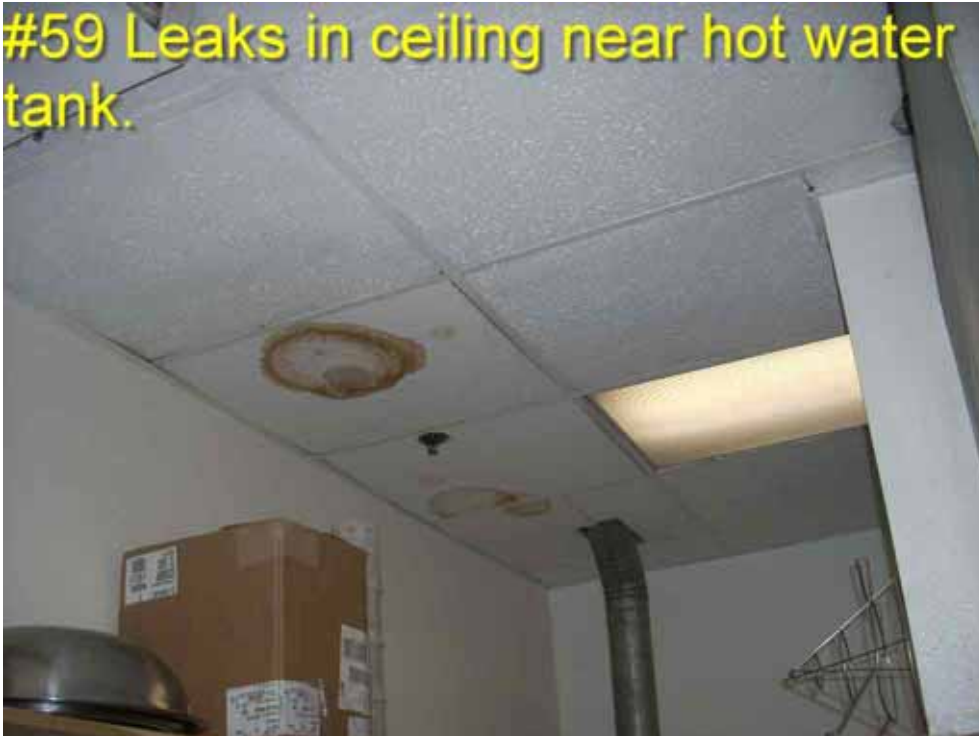
#59 Leaks in ceiling near hot water tank.

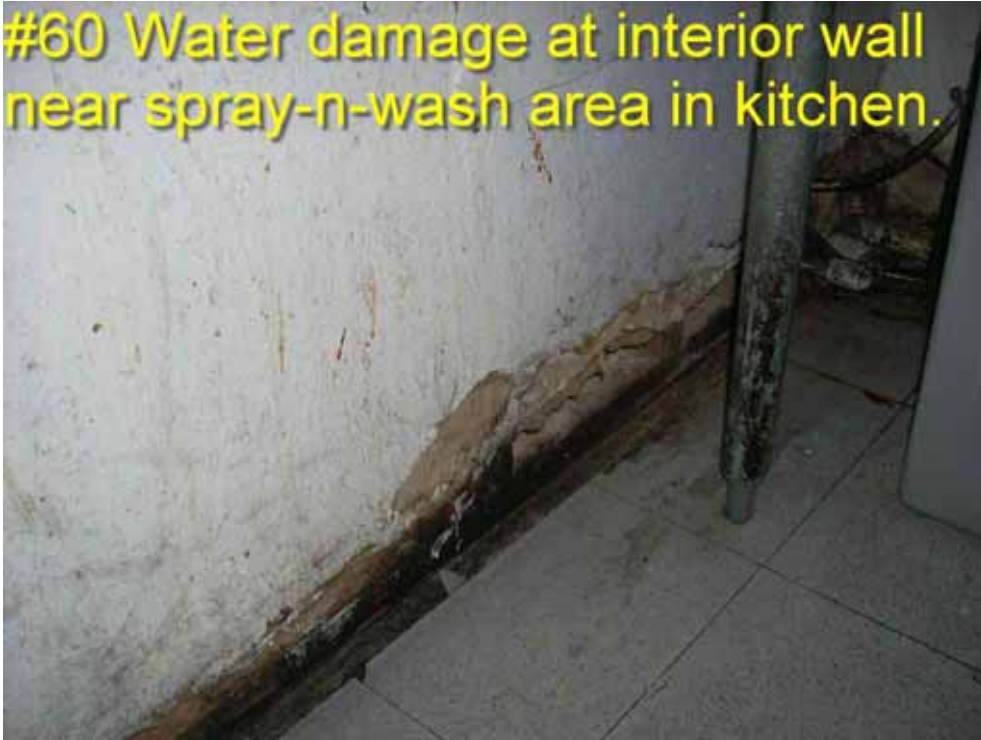
#60 Water damage at interior wall near spray-n-wash area in kitchen.

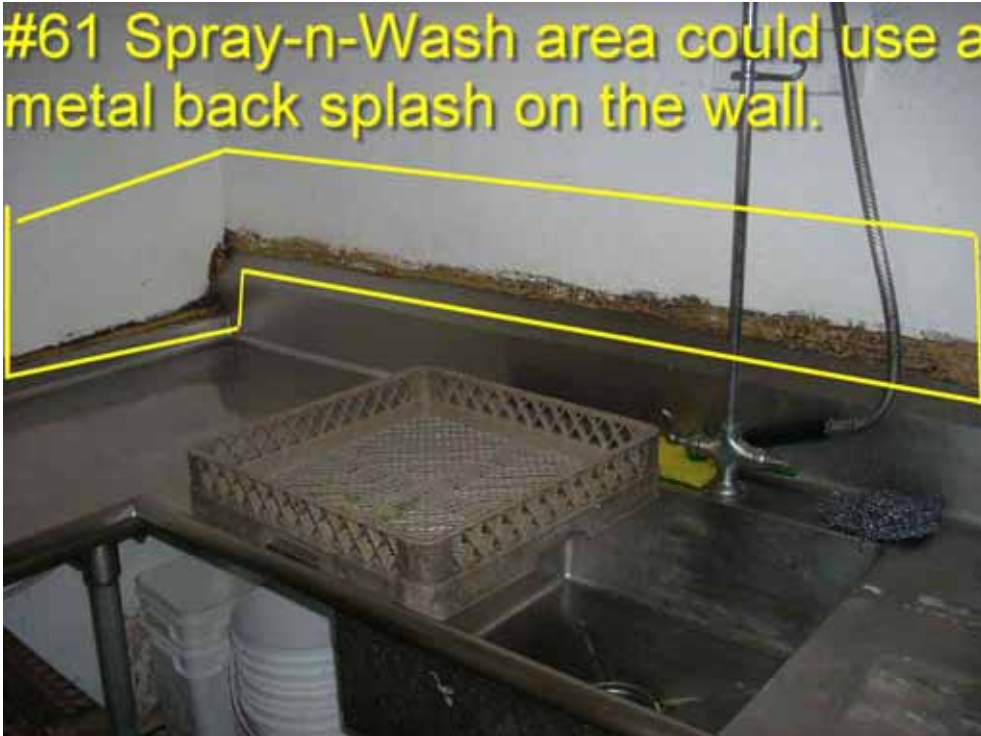
#61 Spray-n-Wash area could use a metal back splash on the wall.

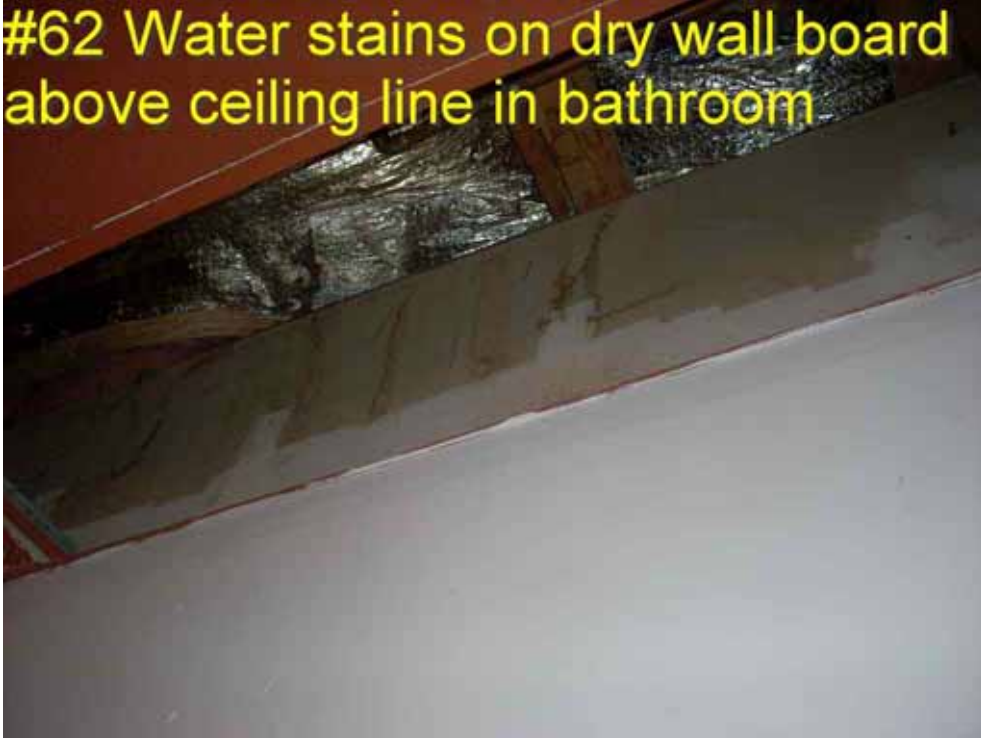
#62 Water stains on dry wall board above ceiling line in bathroom

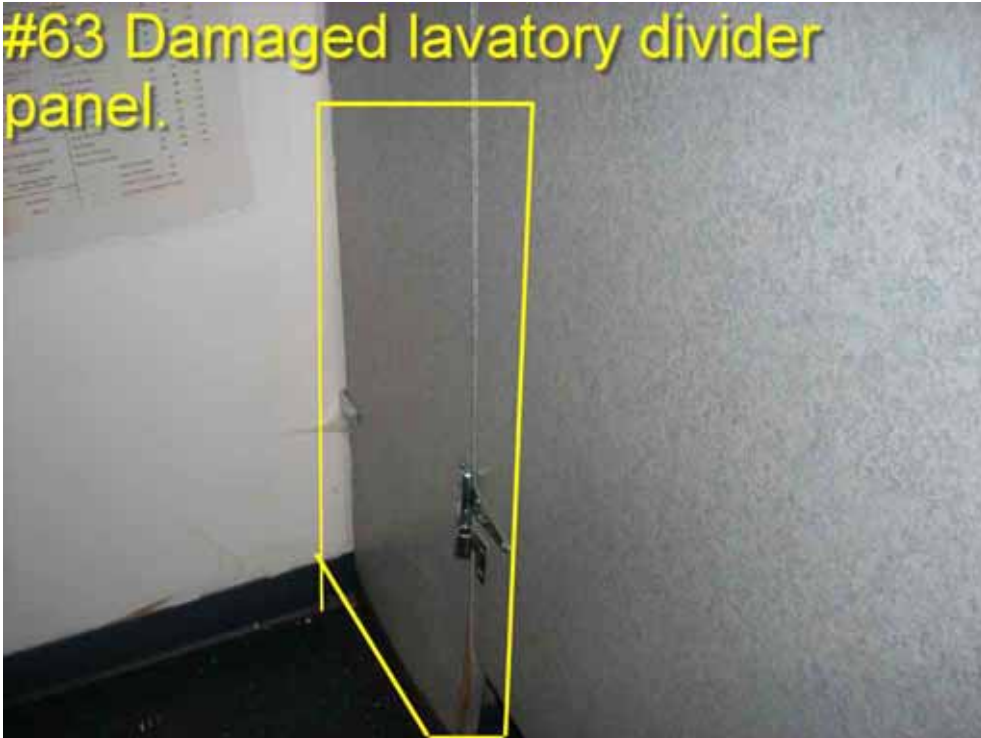
#63 Damaged lavatory divider panel.

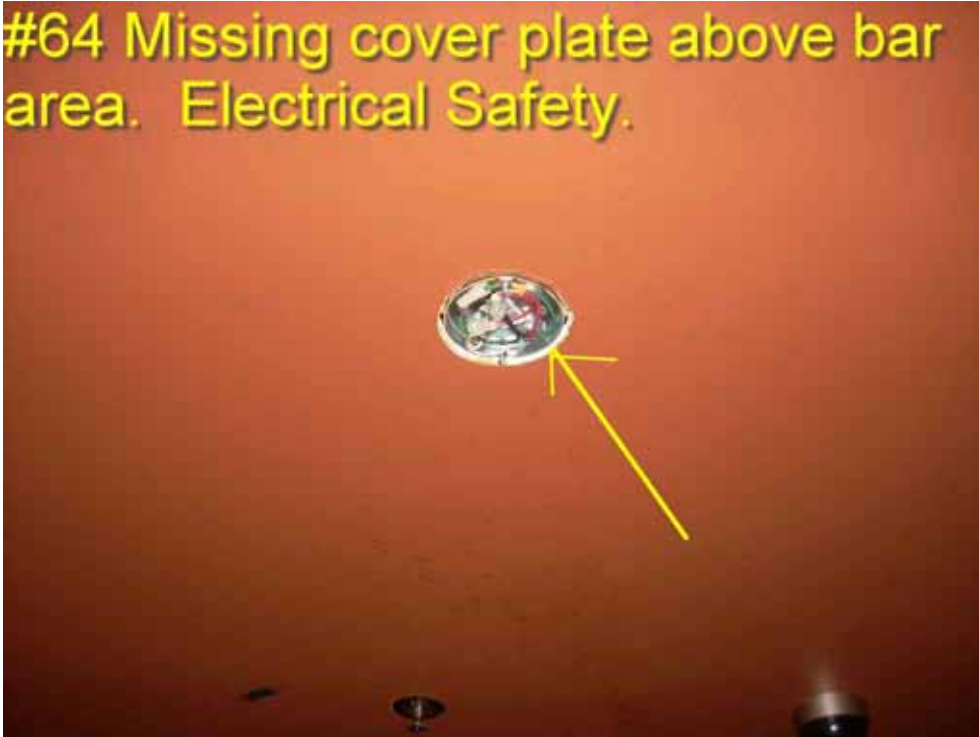
#64 Missing cover plate above bar area. Electrical Safety.

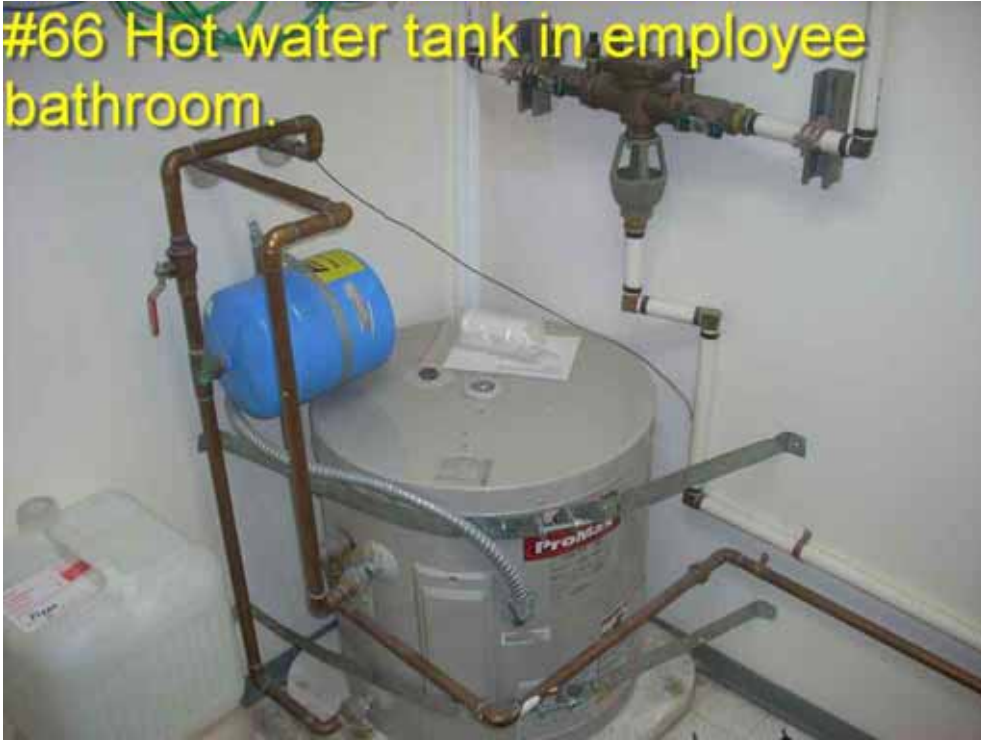
- c. Unit-108 has a significant hole in the floor of the fire control room. This should be filled or covered to keep people safe. (See Photo#50)
- d. Two of the units (104 & 103 ) have hot water tanks in the bathrooms. This is not permitted by building codes and is considered unsafe. The one in Unit-104 is missing the piping from the TPR valve to the outside. (See Photo#56, 66)

#66 Hot water tank in employee bathroom.
