## Structural Building Inspection Report

INSPECTION DATE: November 19, 2009

**Address of Residence Inspected:** 3901 & 3895 NE 4<sup>th</sup> St, Renton WA  
98056

**Type of Residence:** Single Story Strip Mall. Two Buildings

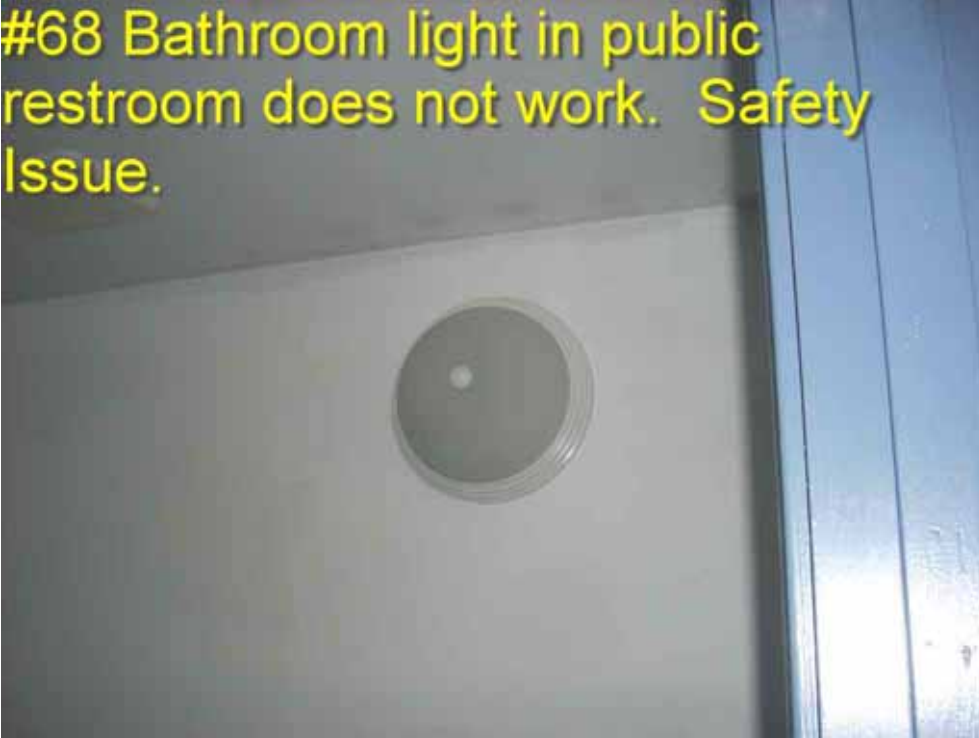
- e. The bathroom light in Unit-102 does not operate. This is a possible litigation issue. (See Photo#68)
- f. The parking lot light pole near the NW corner area is leaning significantly. (See Photo#95)

#68 Bathroom light in public restroom does not work. Safety Issue.

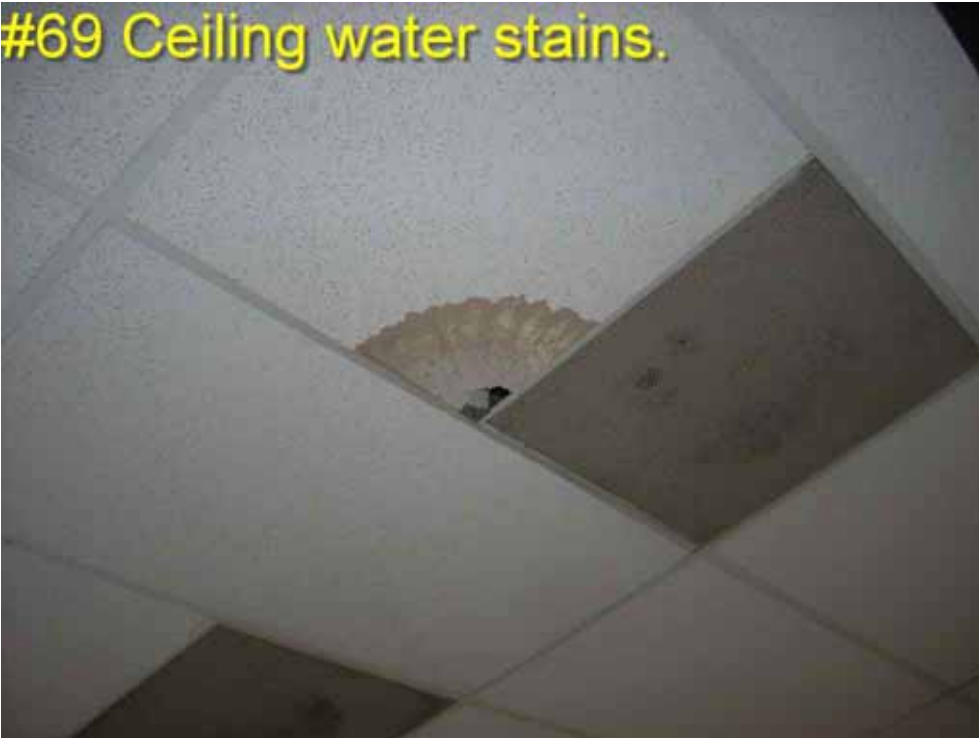
#69 Ceiling water stains.

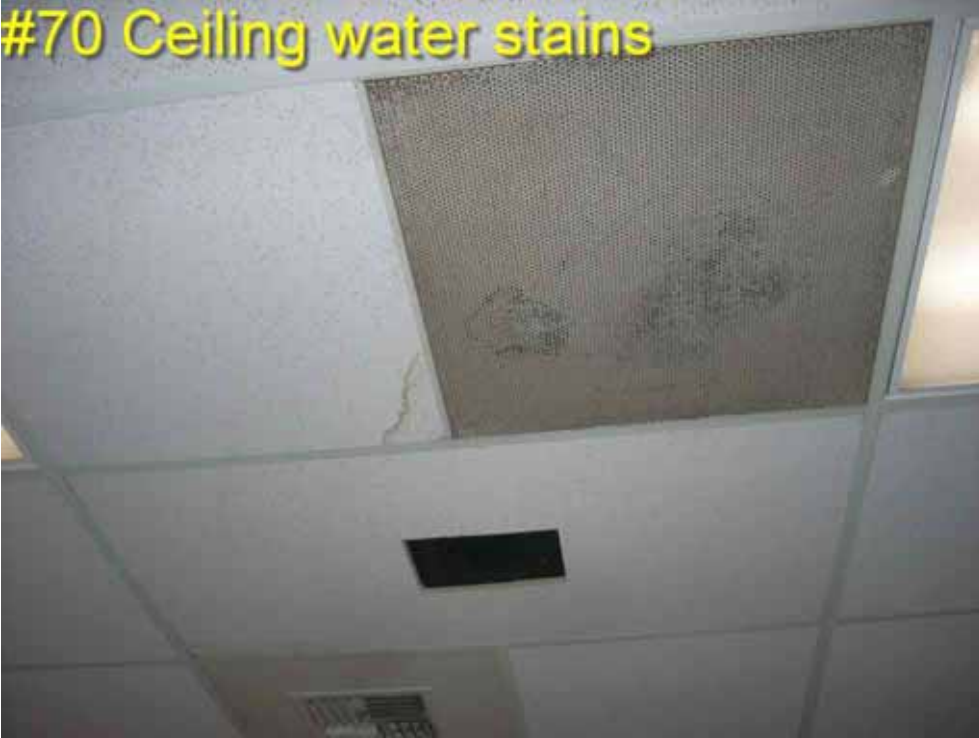
#70 Ceiling water stains

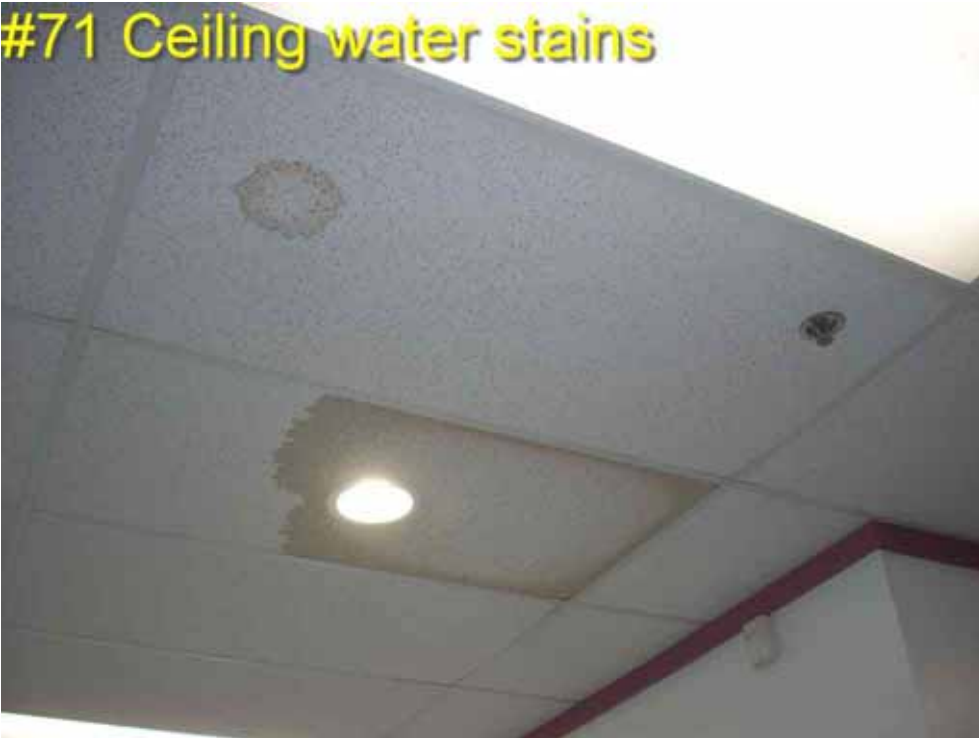
#71 Ceiling water stains

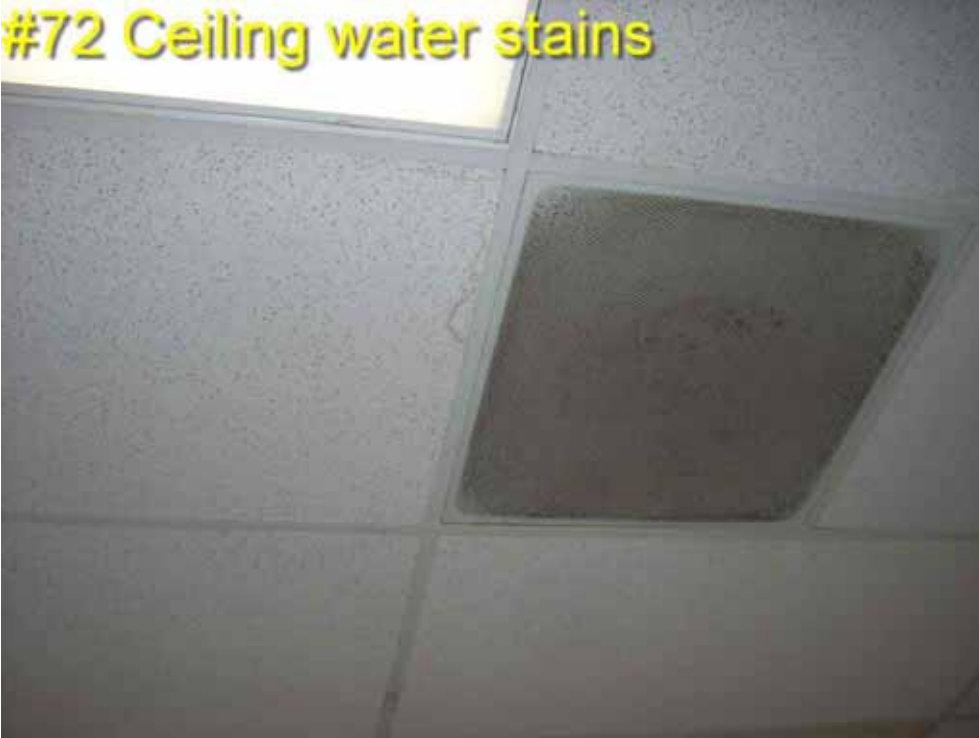
#72 Ceiling water stains

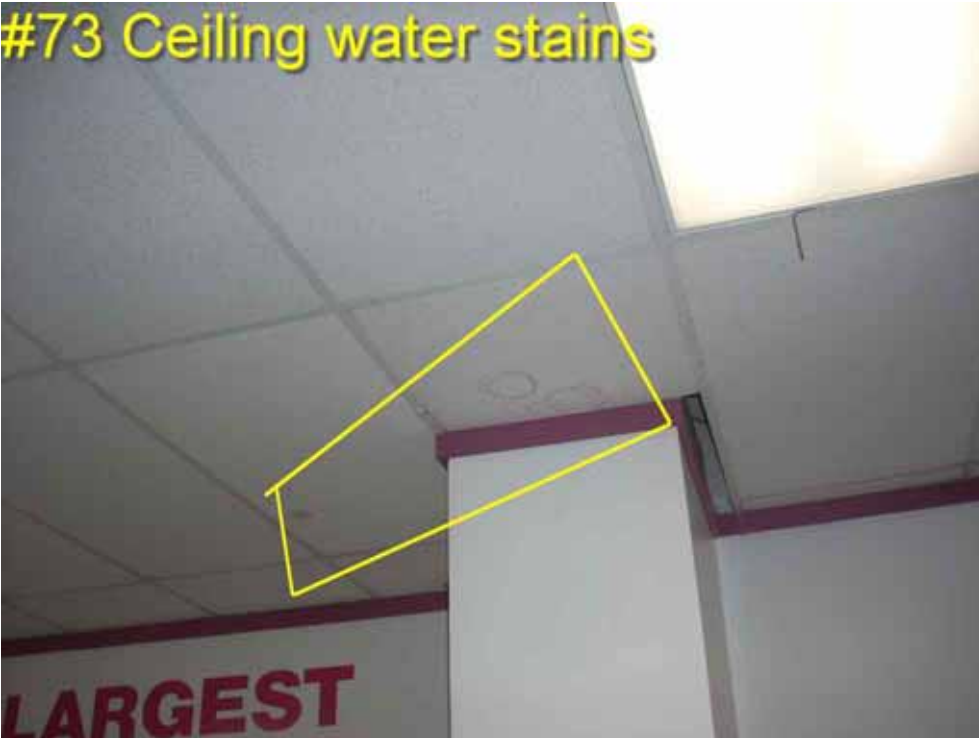
#73 Ceiling water stains

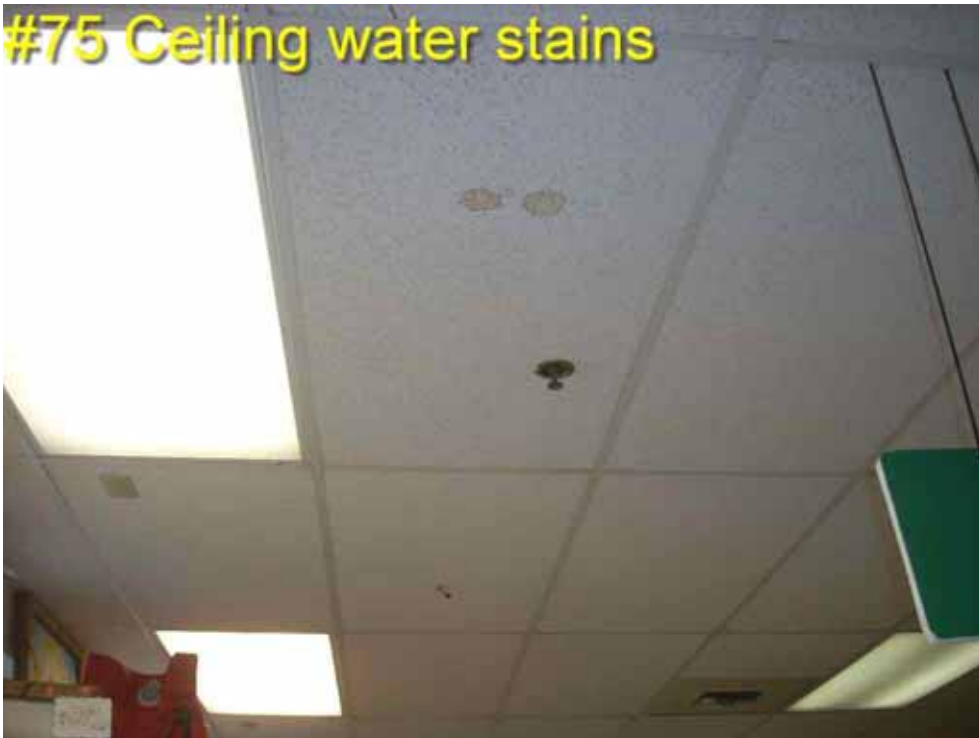
#75 Ceiling water stains

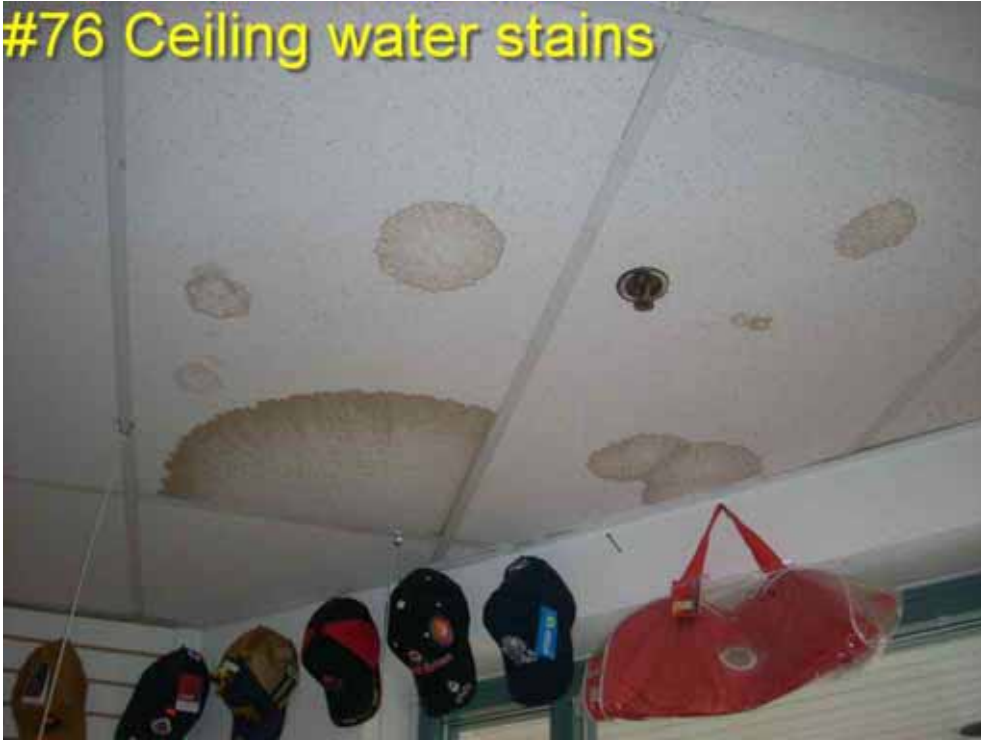
#76 Ceiling water stains

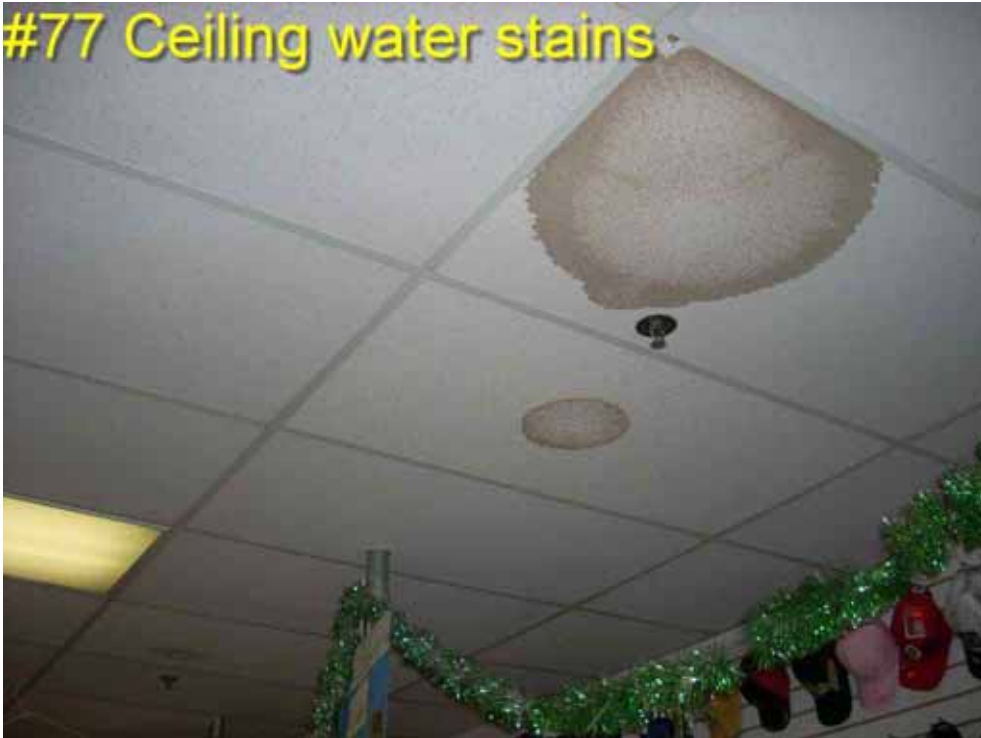
#77 Ceiling water stains

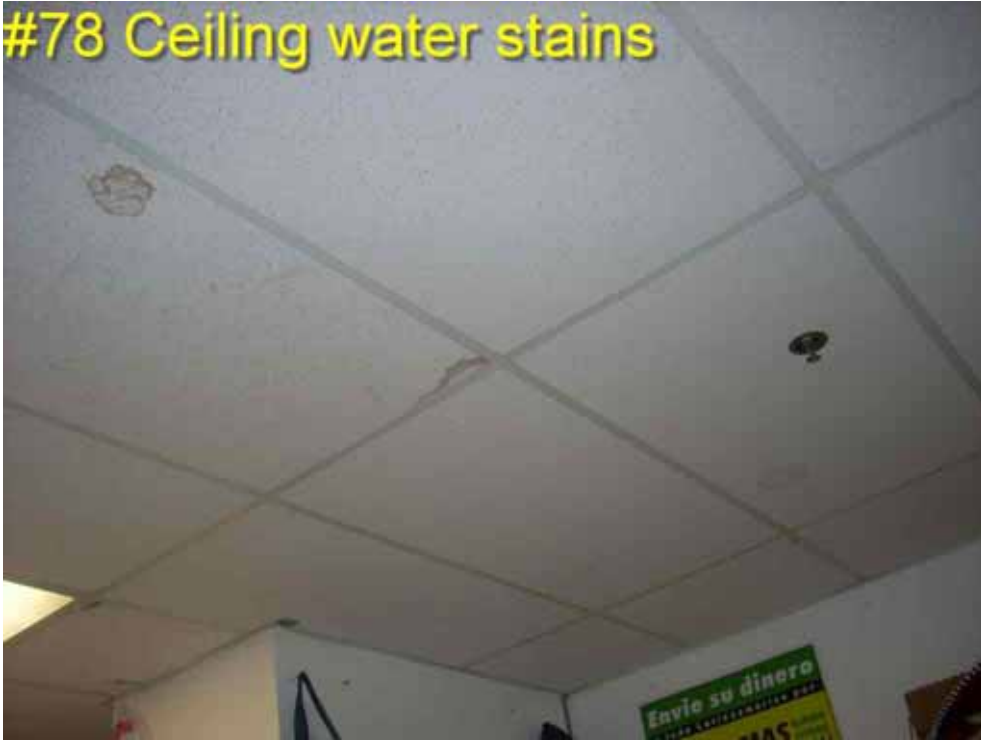
#78 Ceiling water stains

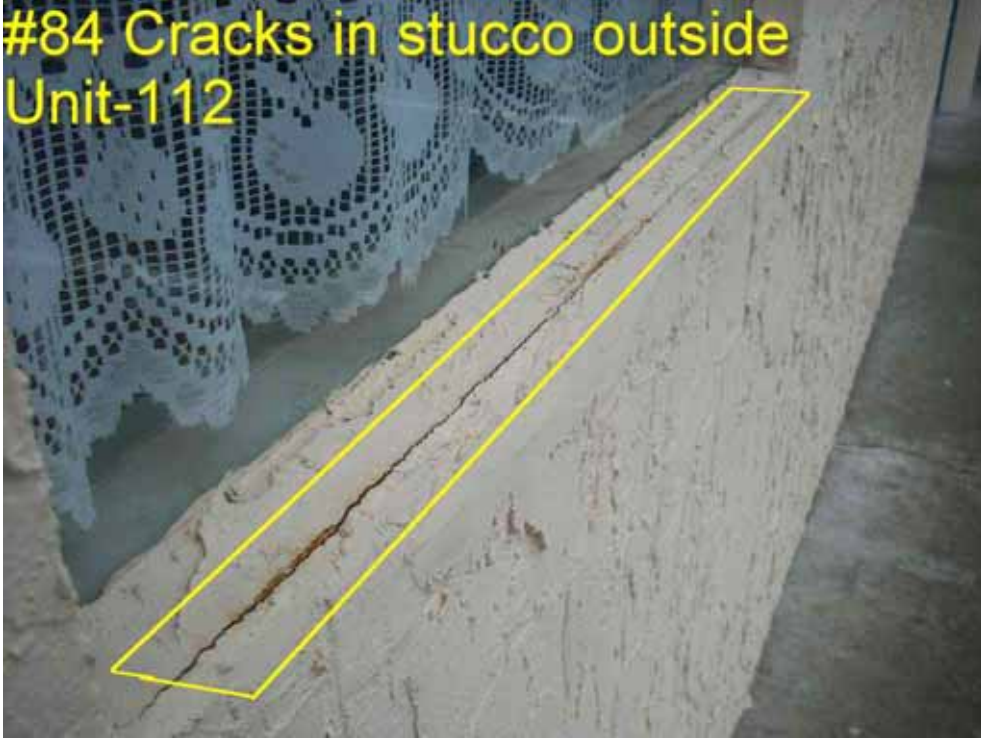
#84 Cracks in stucco outside Unit-112

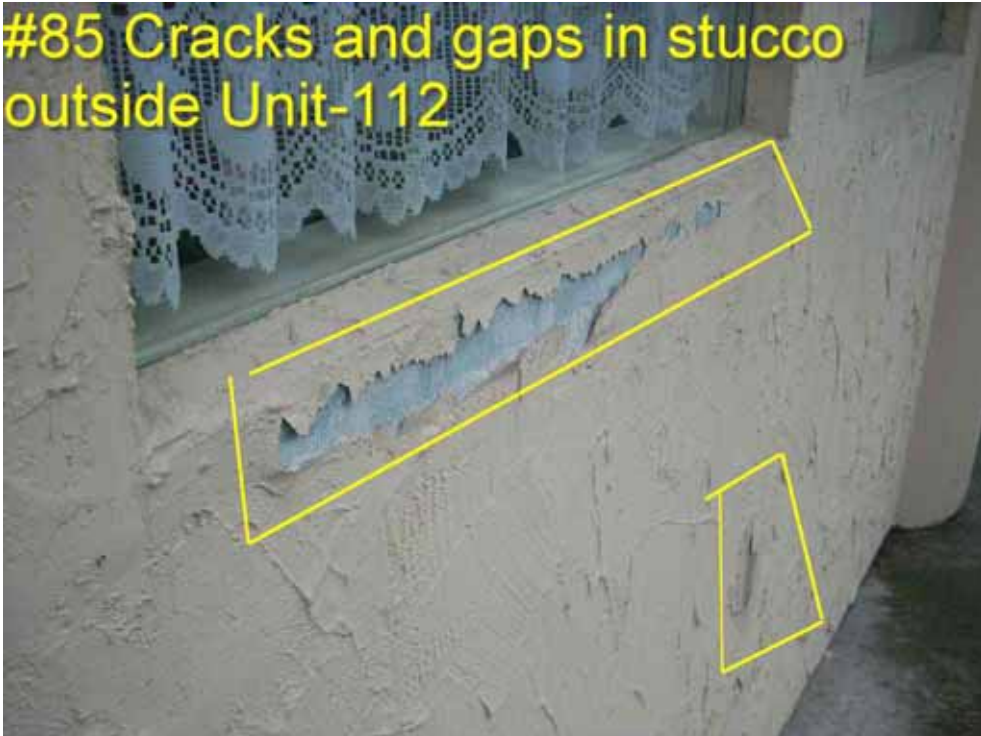
#85 Cracks and gaps in stucco outside Unit-112

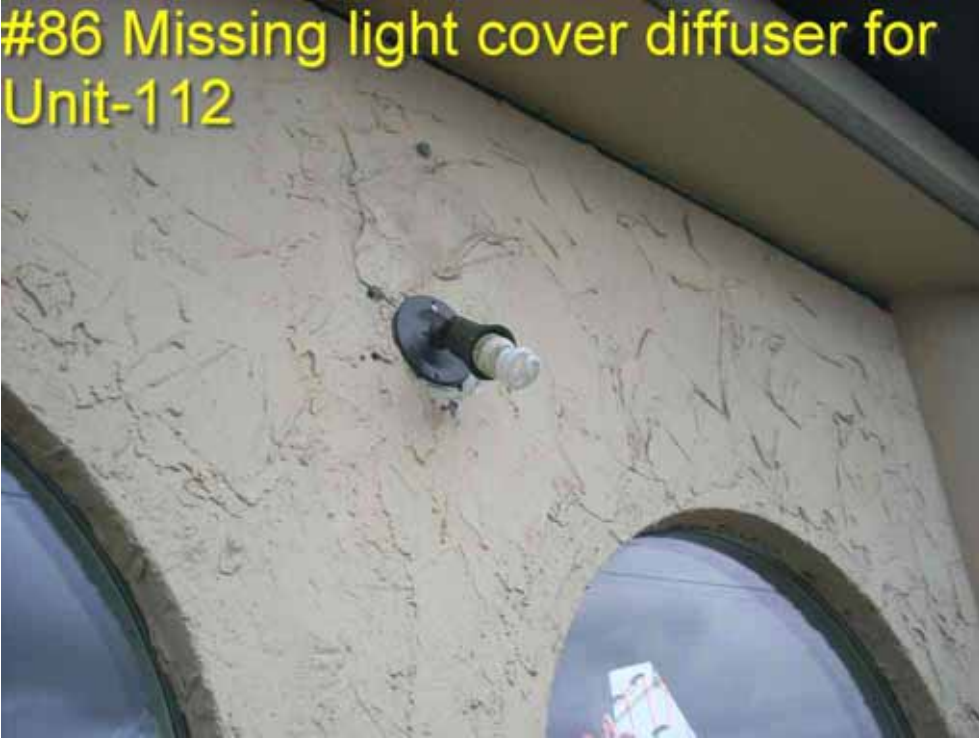
16. Light fixture cover is missing on the north end of Unit-112. (See Photo#86)
17. There is some stucco damage to Bldg.3901 due to high delivery truck collision. (See Photo#88, 89)

#86 Missing light cover diffuser for Unit-112

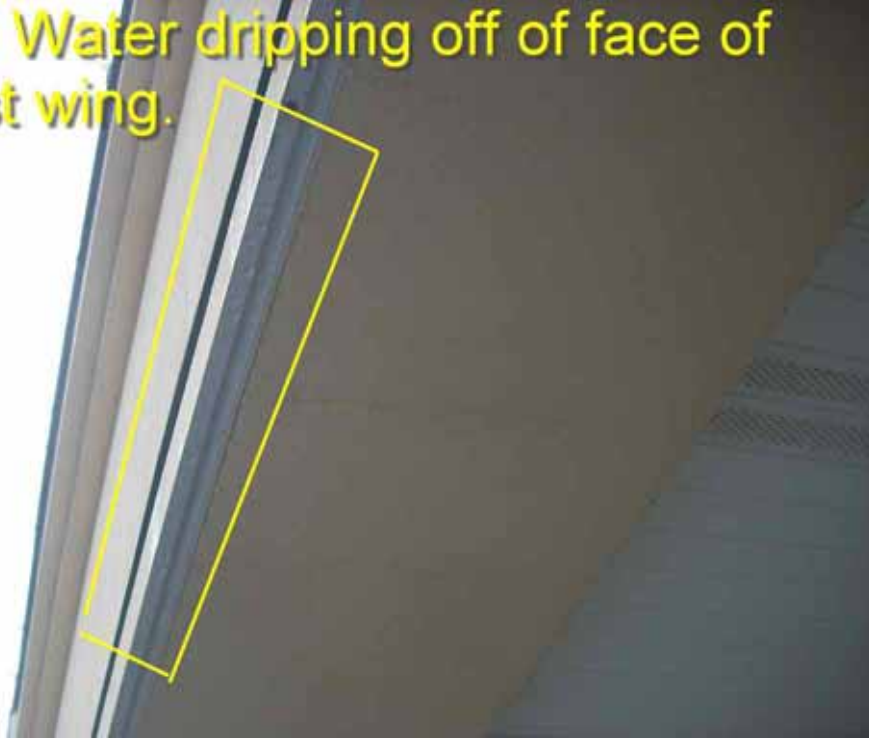
#90 Water dripping off of face of west wing.

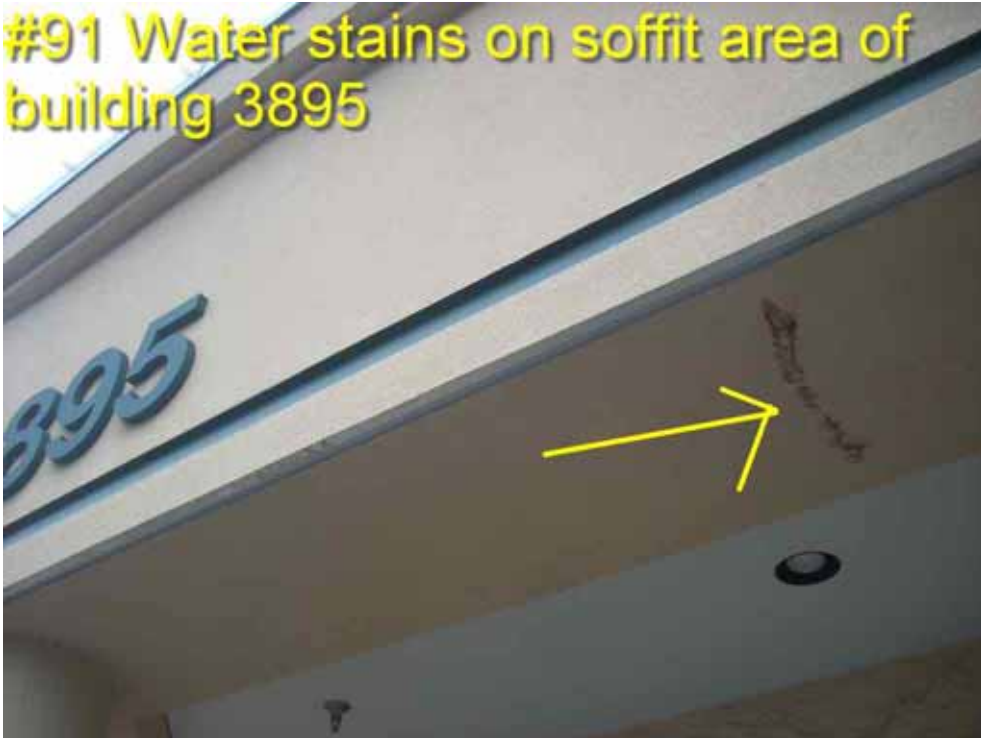
#91 Water stains on soffit area of building 3895
