## Structural Building Inspection Report

INSPECTION DATE: November 19, 2009

**Address of Residence Inspected:** 3901 & 3895 NE 4<sup>th</sup> St, Renton WA  
98056

**Type of Residence:** Single Story Strip Mall. Two Buildings

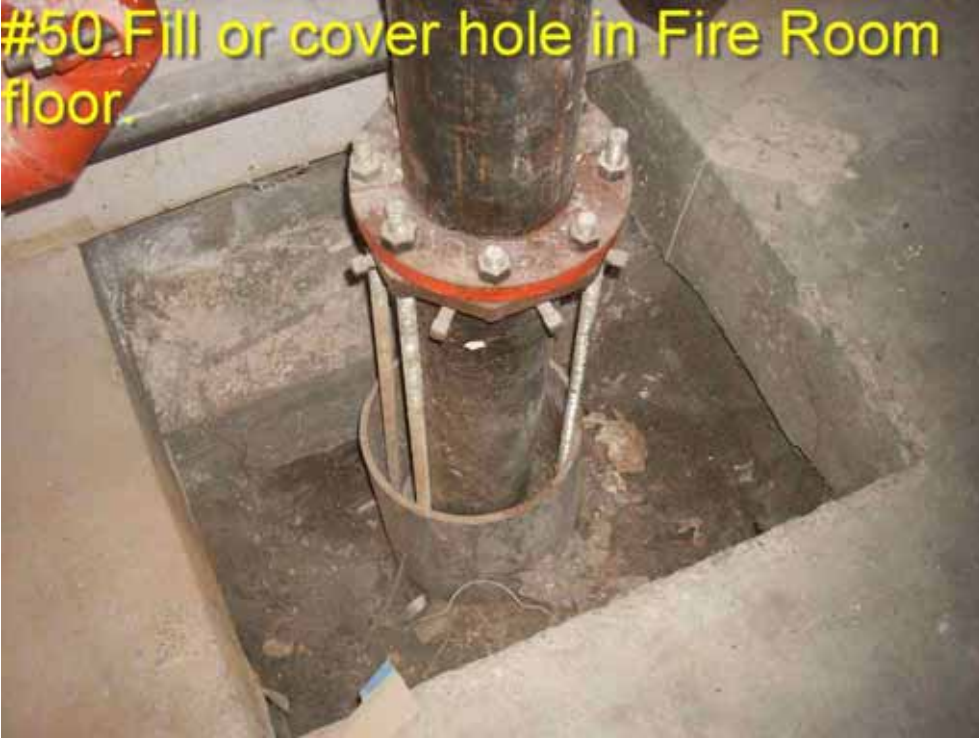
#50 Fill or cover hole in Fire Room floor.
