## Structural Building Inspection Report

INSPECTION DATE: November 19, 2009

**Address of Residence Inspected:** 3901 & 3895 NE 4<sup>th</sup> St, Renton WA  
98056

**Type of Residence:** Single Story Strip Mall. Two Buildings

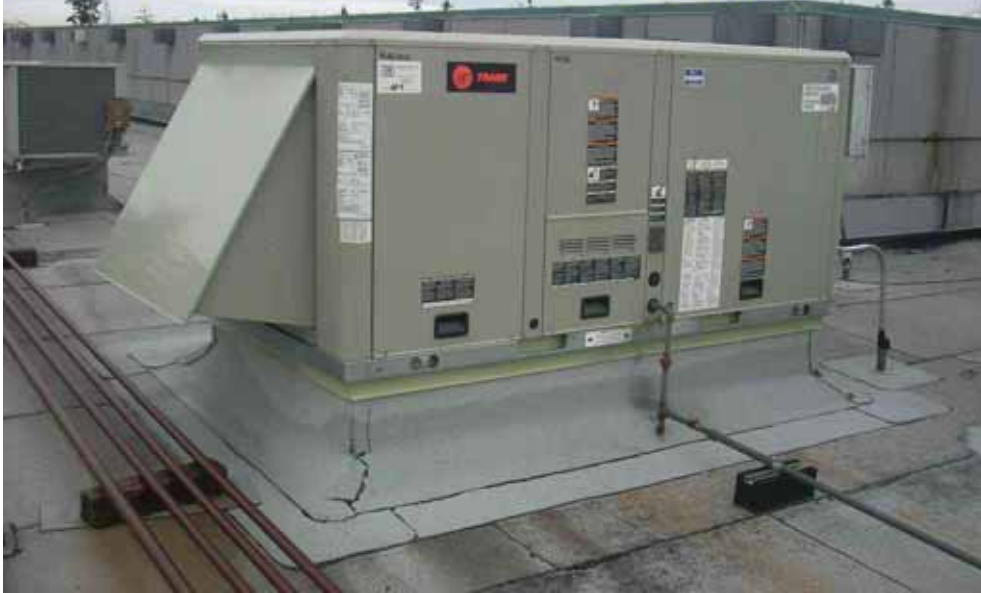
#5 Four of the fifteen HVAC units on the roof are new for bldg. 3901

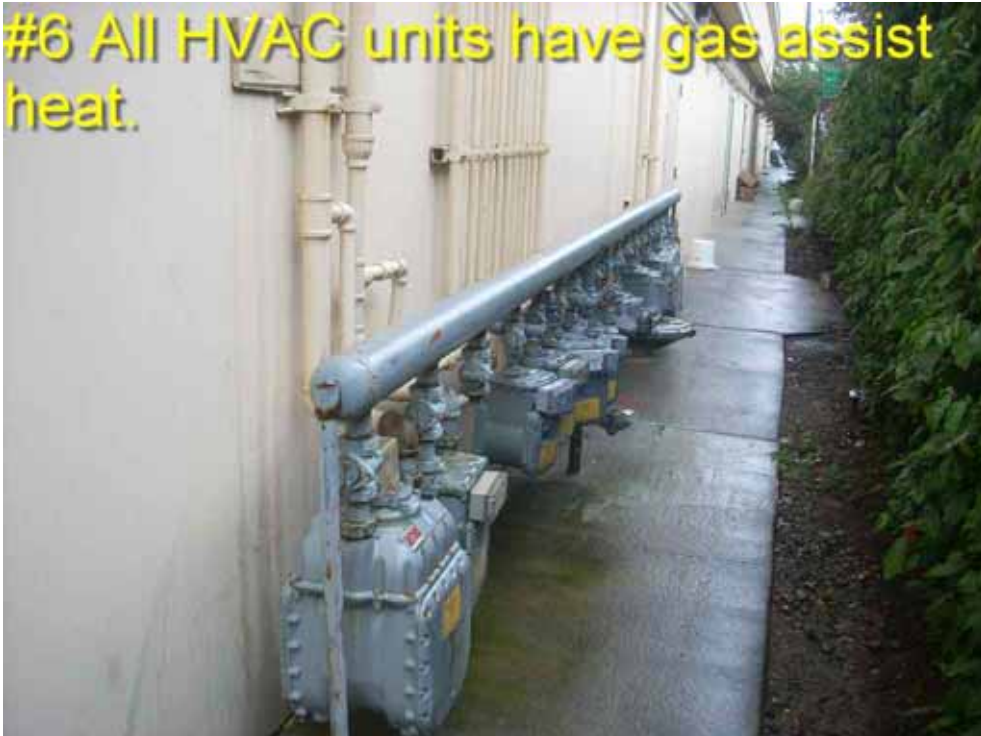
#6 All HVAC units have gas assist heat.

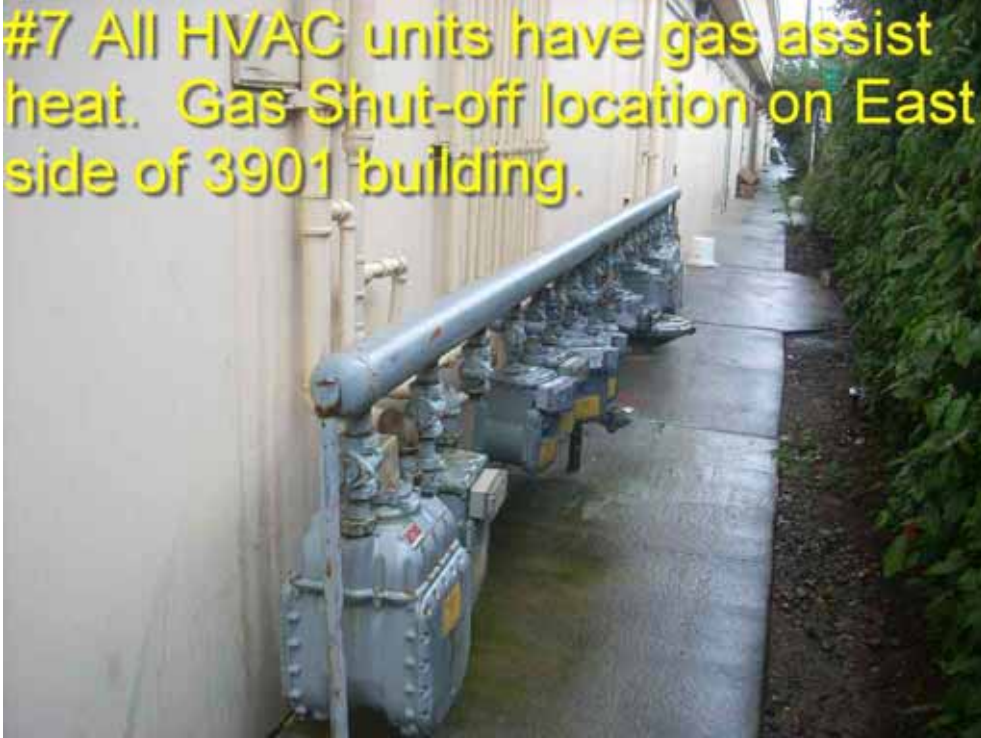
#7 All HVAC units have gas assist heat. Gas Shut-off location on East side of 3901 building.

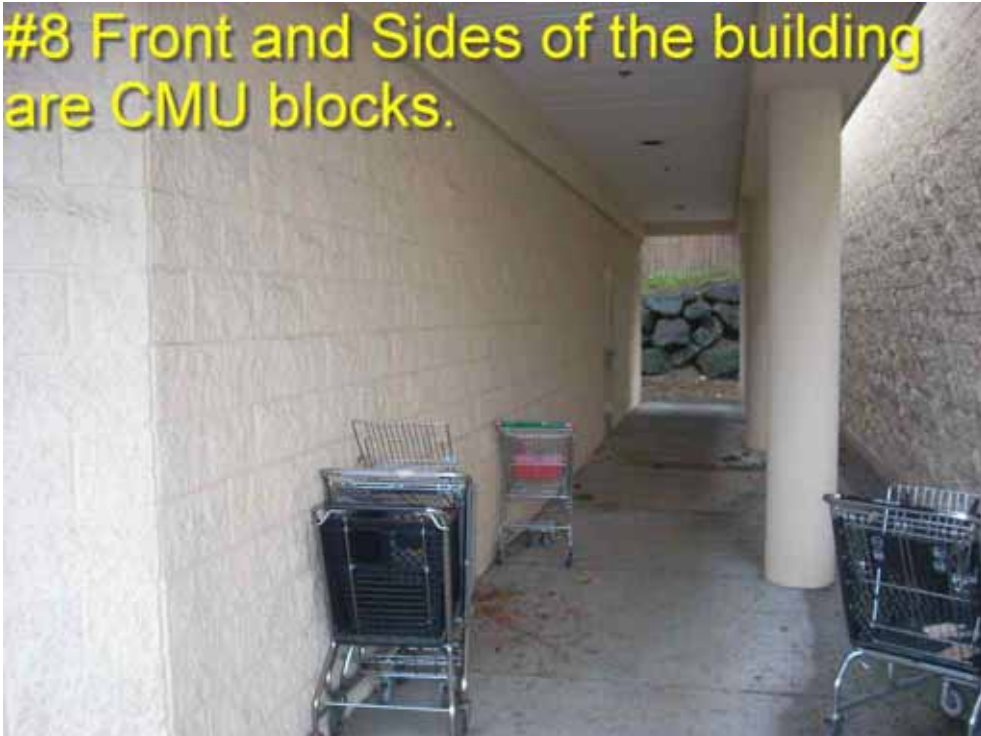
#8 Front and Sides of the building are CMU blocks.

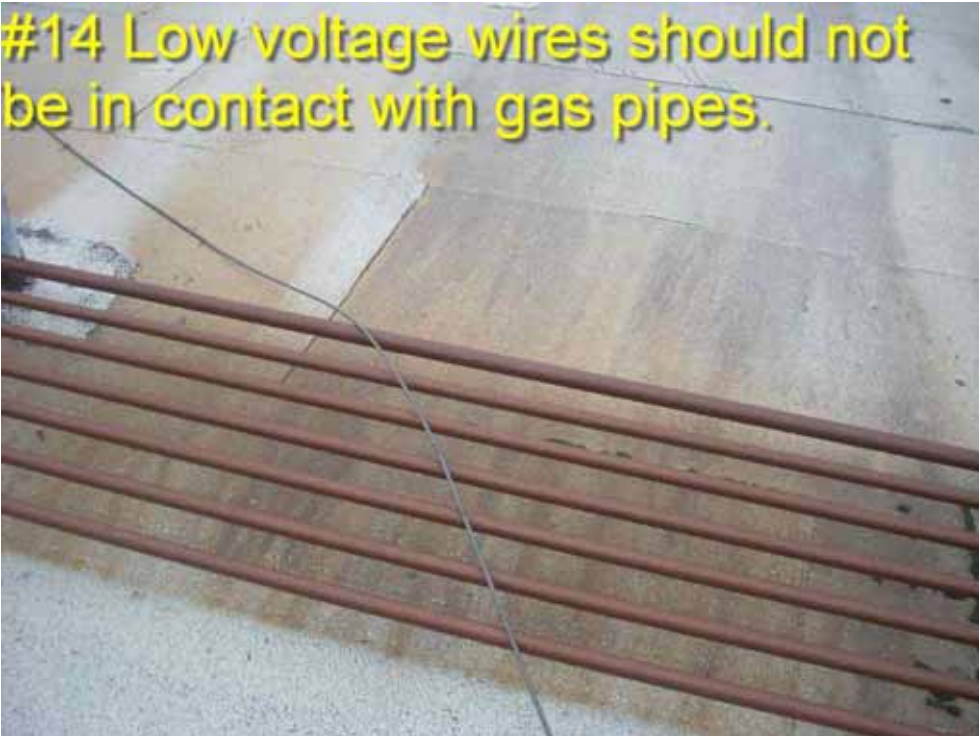
#14 Low voltage wires should not be in contact with gas pipes.

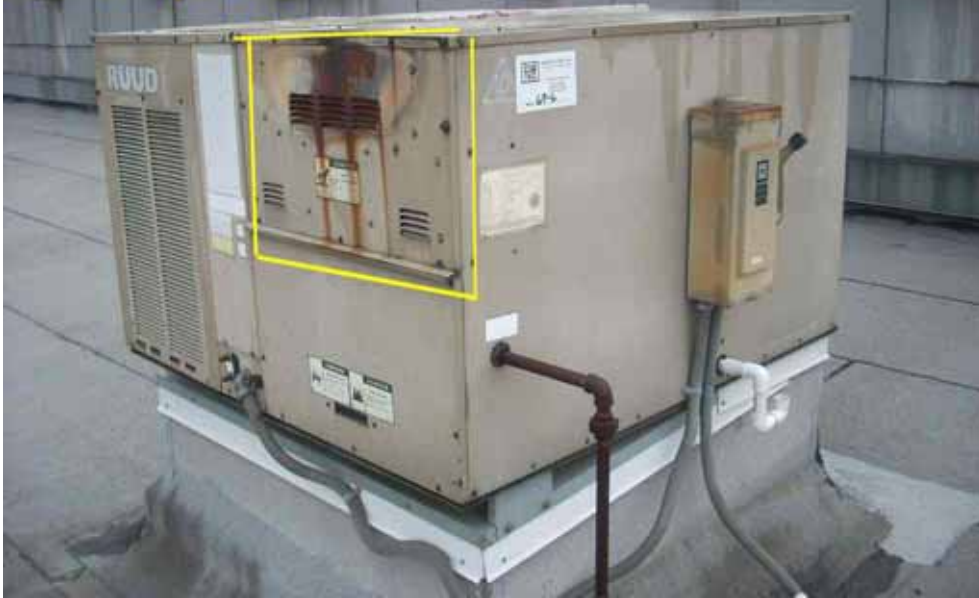
#15 GP-6 needs new combustion cover plate.

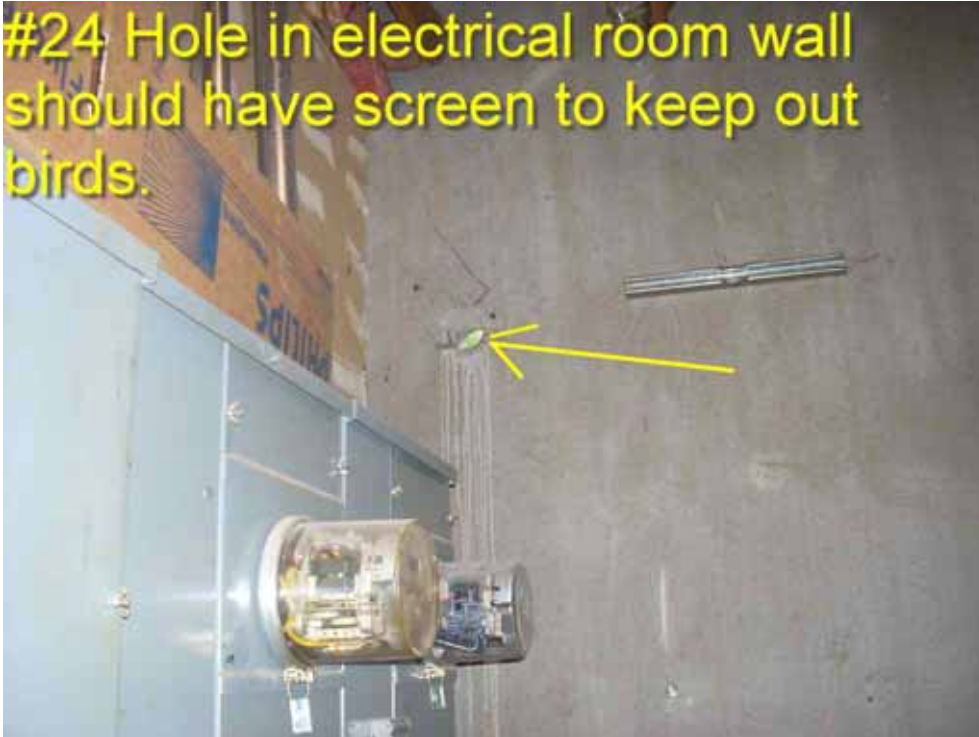
#24 Hole in electrical room wall should have screen to keep out birds.

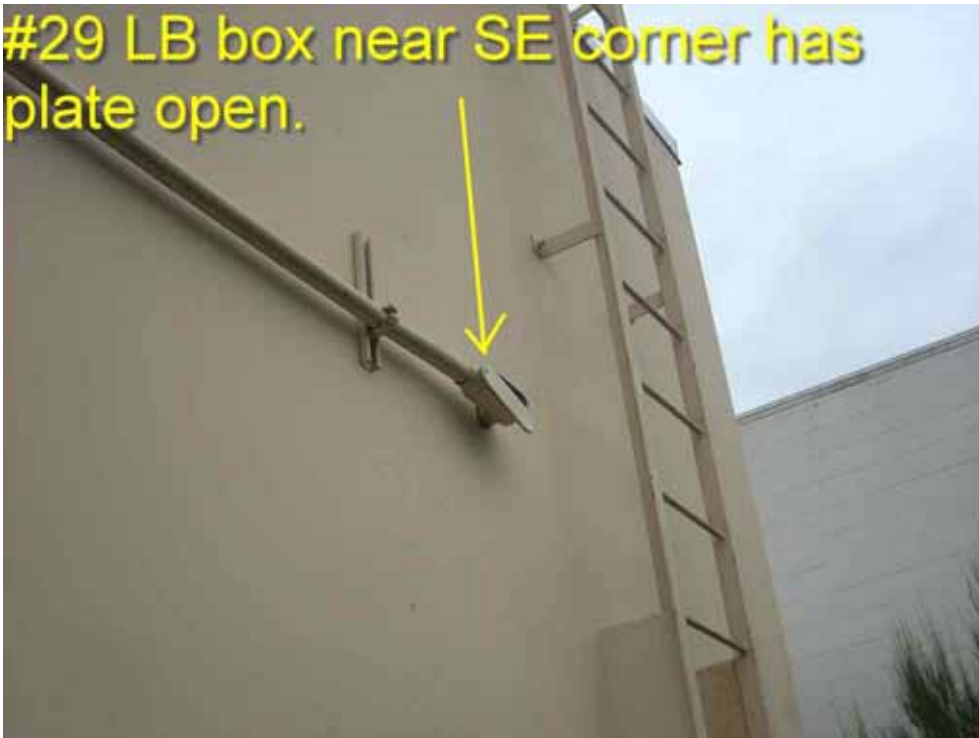
#29 LB box near SE corner has plate open.

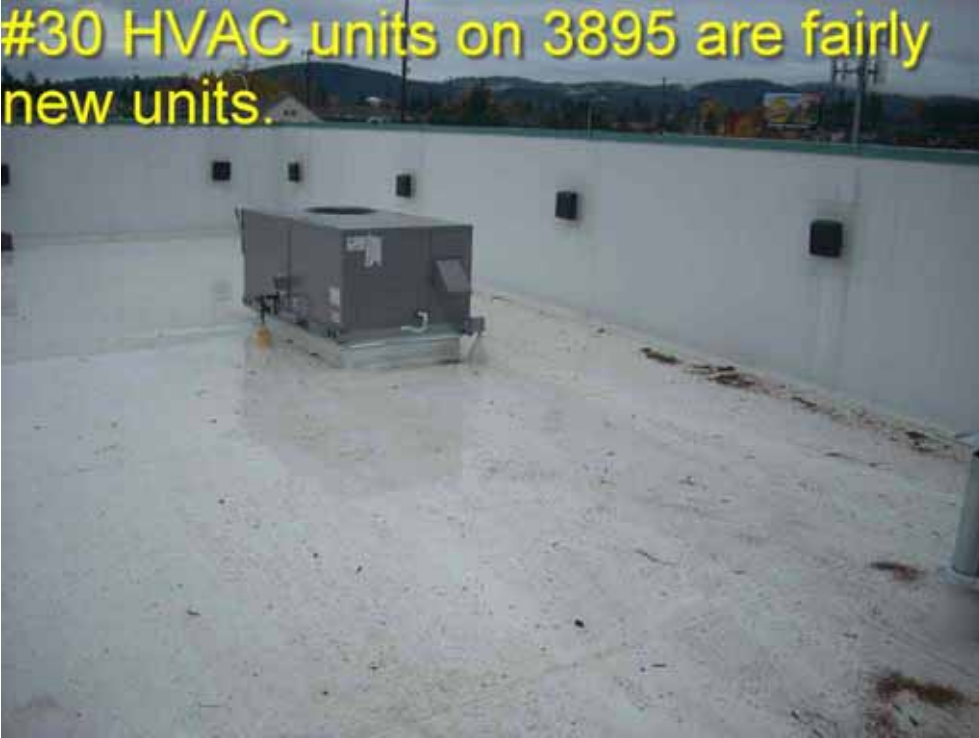
#30 HVAC units on 3895 are fairly new units.

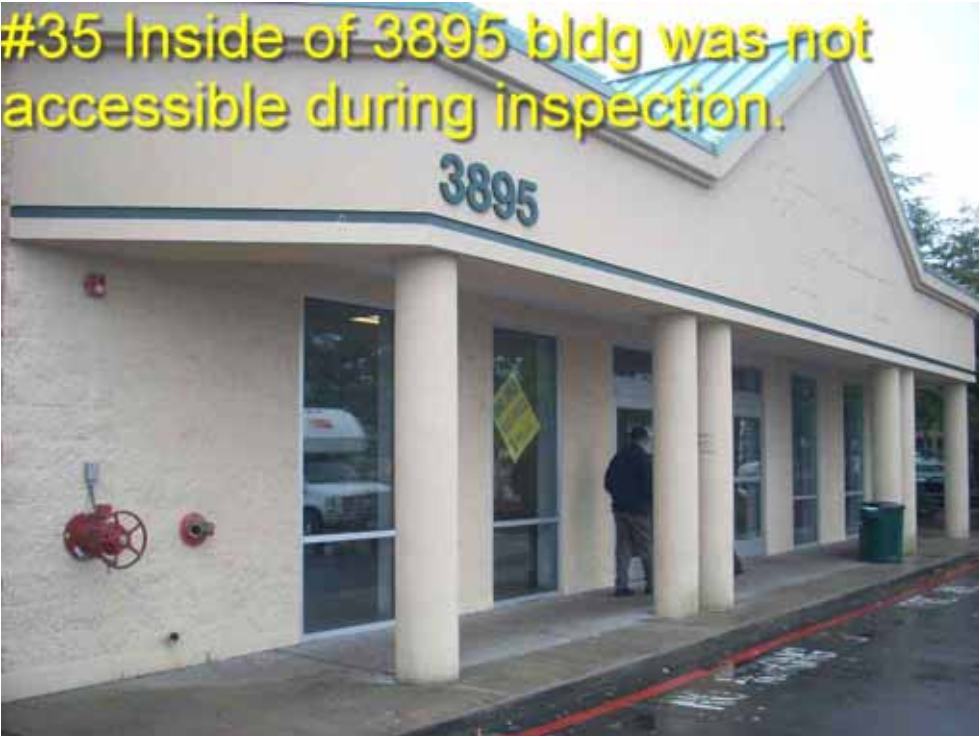
#35 Inside of 3895 bldg was not accessible during inspection.

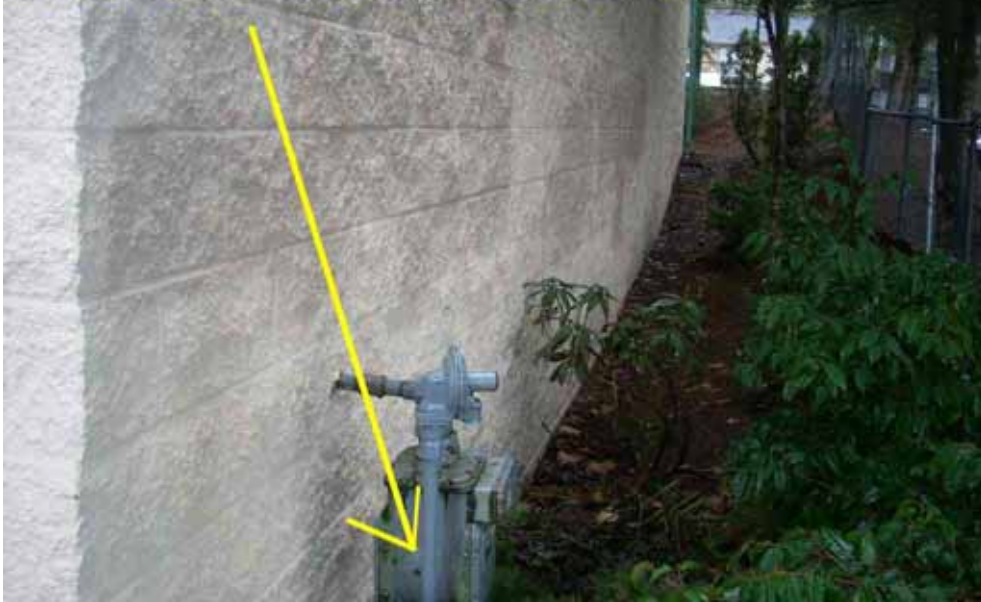
#36 Gas shut off valve to 3895 is on west side near NW corner.

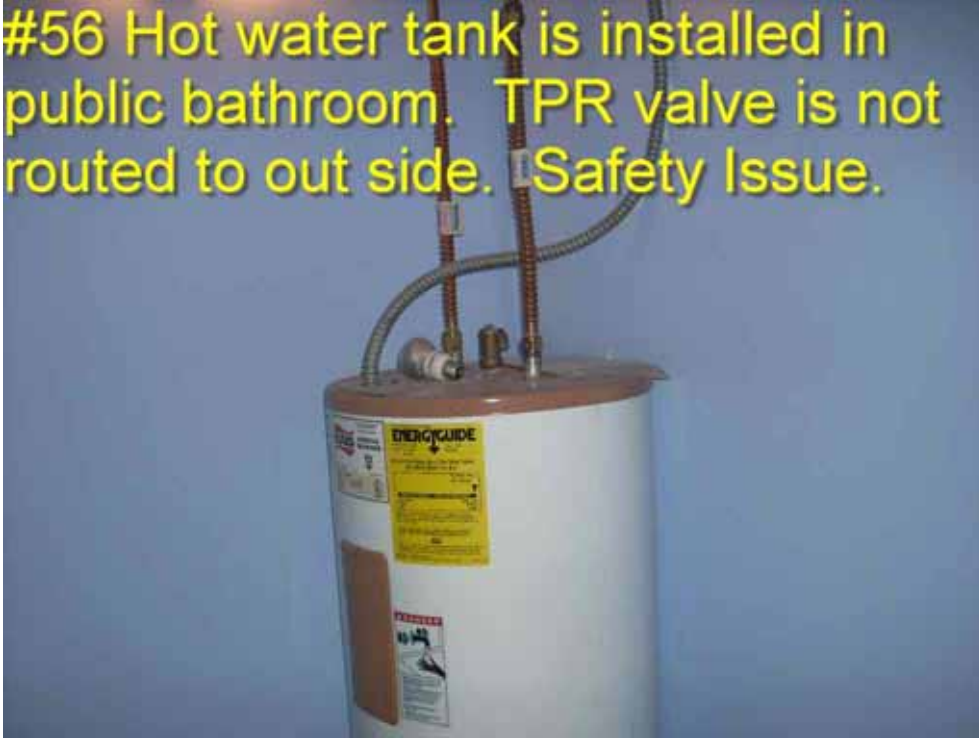
#56 Hot water tank is installed in public bathroom. TPR valve is not routed to outside. Safety Issue.

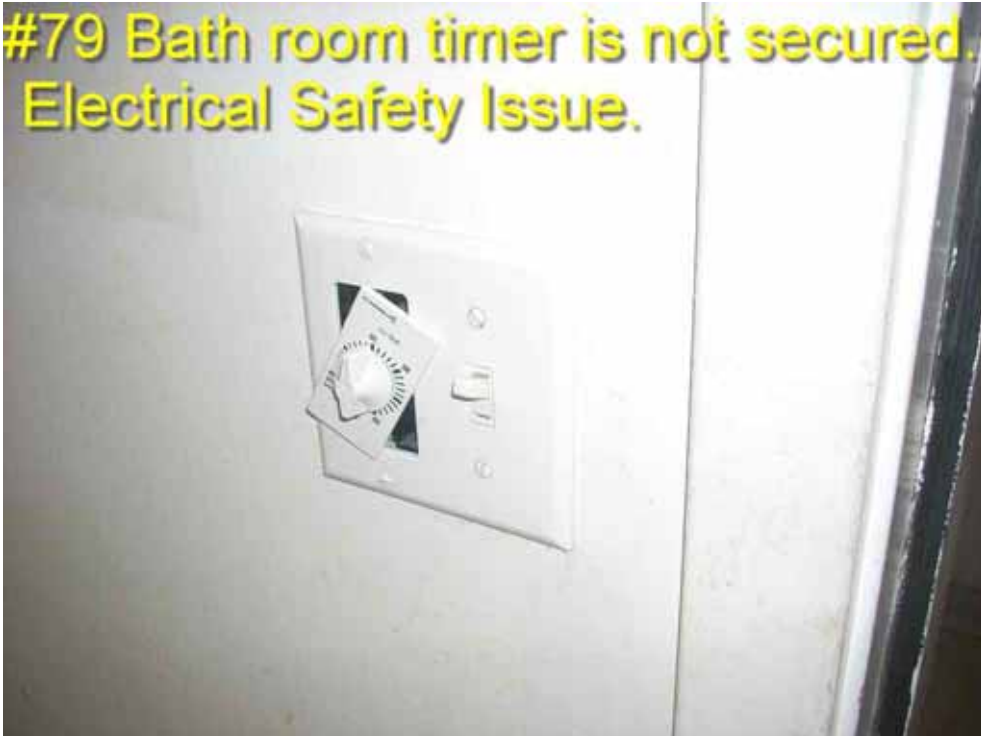
#79 Bath room timer is not secured.  
Electrical Safety Issue.

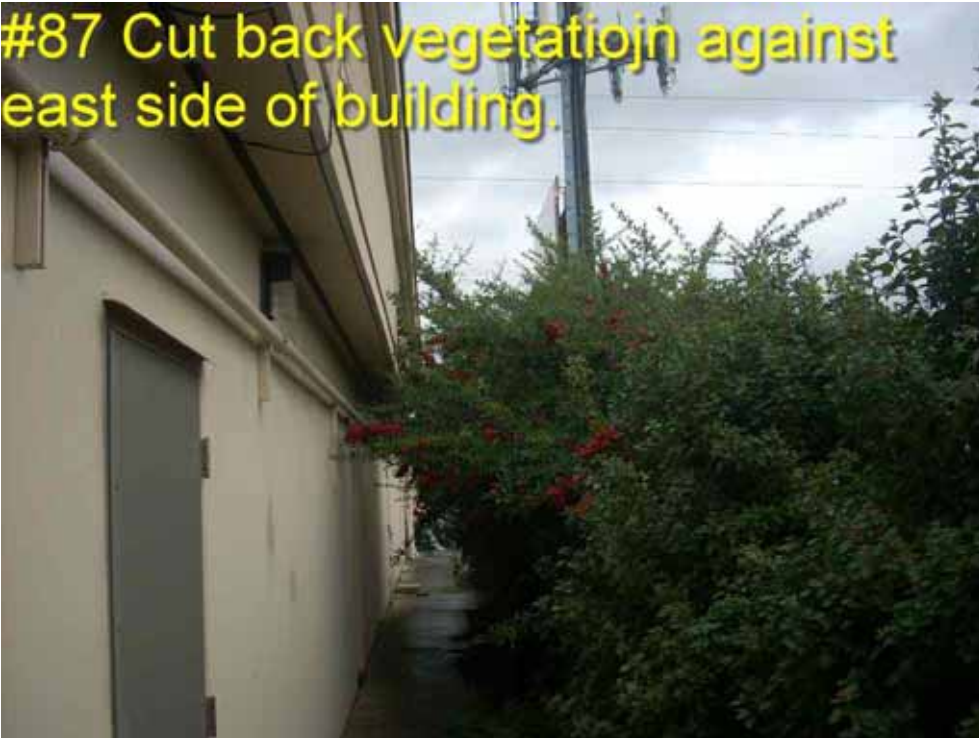
#87 Cut back vegetation against east side of building.

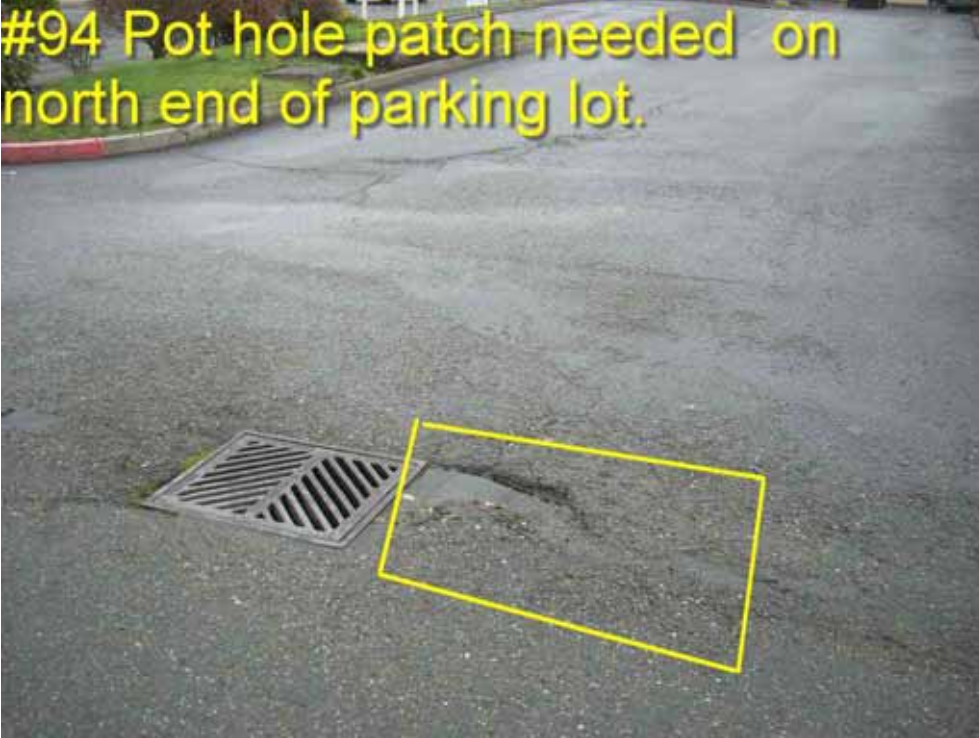
#94 Pot hole patch needed on north end of parking lot.
